# White Rock Creek Watershed Data Report

August 2014

**THE MEADOWS CENTER**  
FOR WATER AND THE ENVIRONMENT

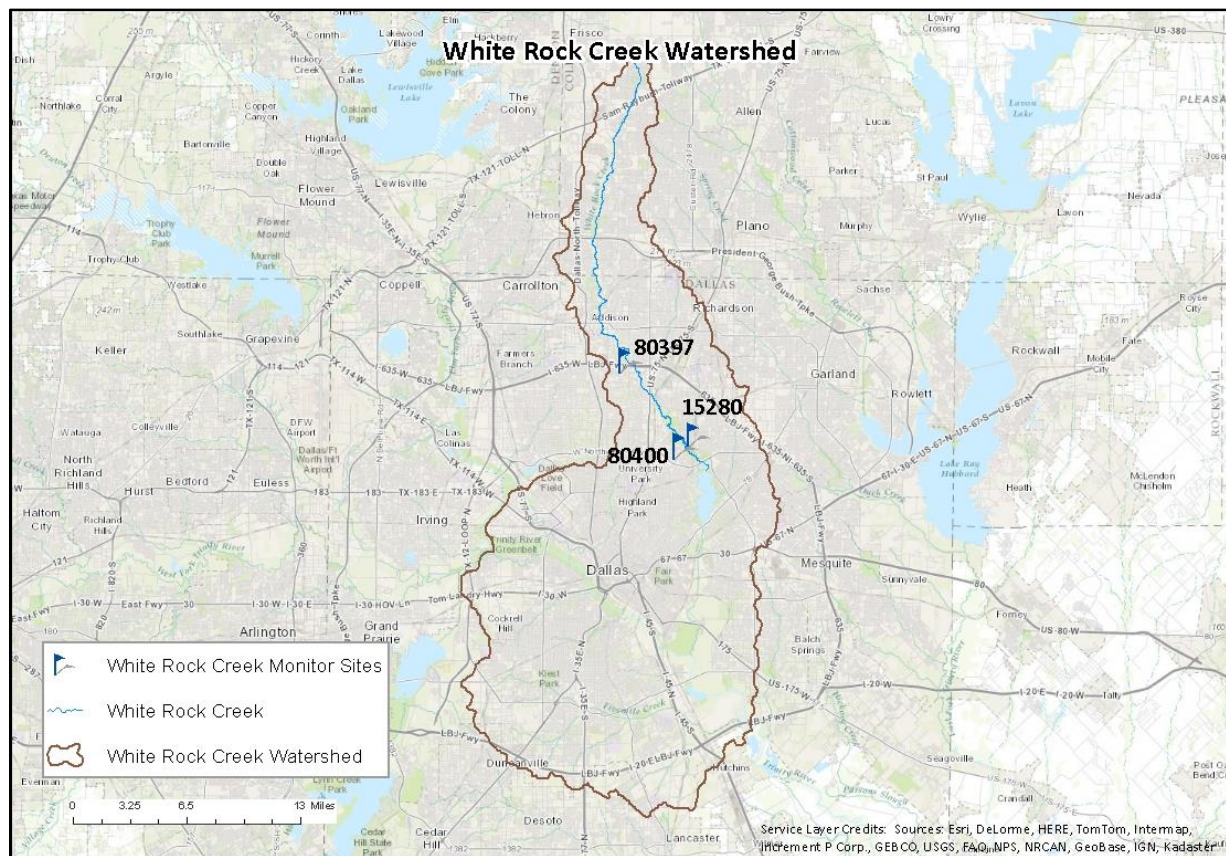
Figure 1: Map of the White Rock Creek Watershed with Texas Stream Team Monitor Sites

Numerous maps were prepared to show spatial variation of the parameters. The parameters mapped include DO, pH, TDS, and *E. coli*. There is also a reference map showing the locations of all active. For added reference points in all maps, layers showing monitoring sites, cities, counties, and major highways were included. All shapefiles were downloaded from reliable federal, state, and local agencies.

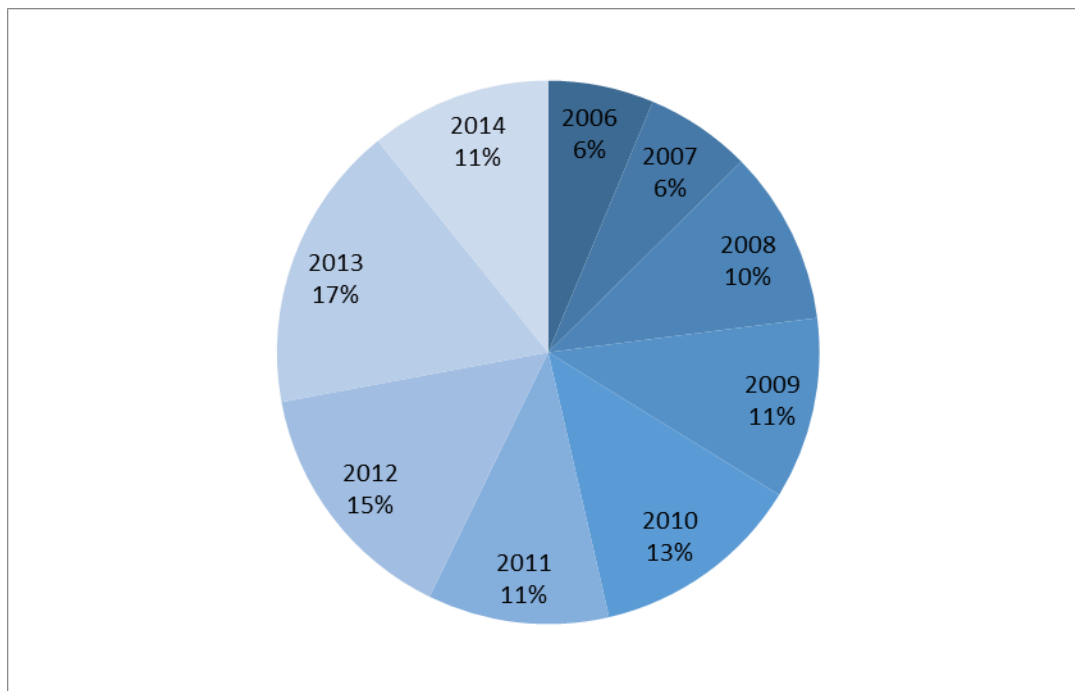
**Figure 2: Breakdown of monitoring events by year.**

Sampling in the White Rock Creek Watershed began in May of 2006 and continue to this day. A total of 222 monitoring events from 3 sites were analyzed. Monthly monitoring occurred on a consistent basis, although there was a decline that occurred during the month of August. Sampling was concentrated during the morning hours between 10:00 and 11:00.

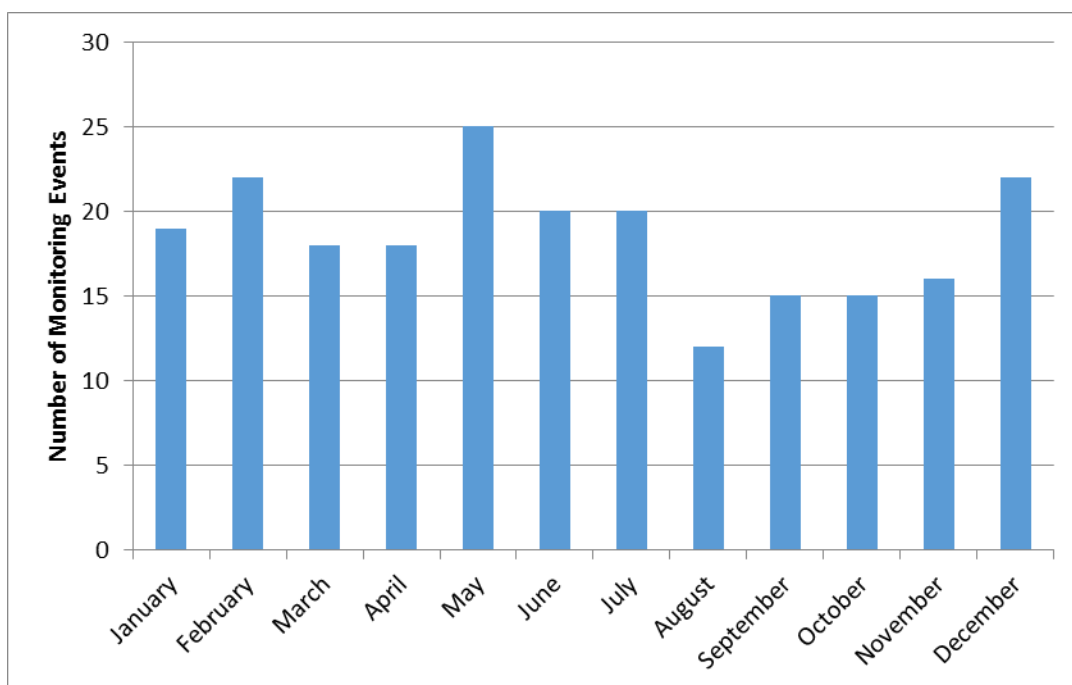
**Figure 3: Breakdown of monitoring events by month.**

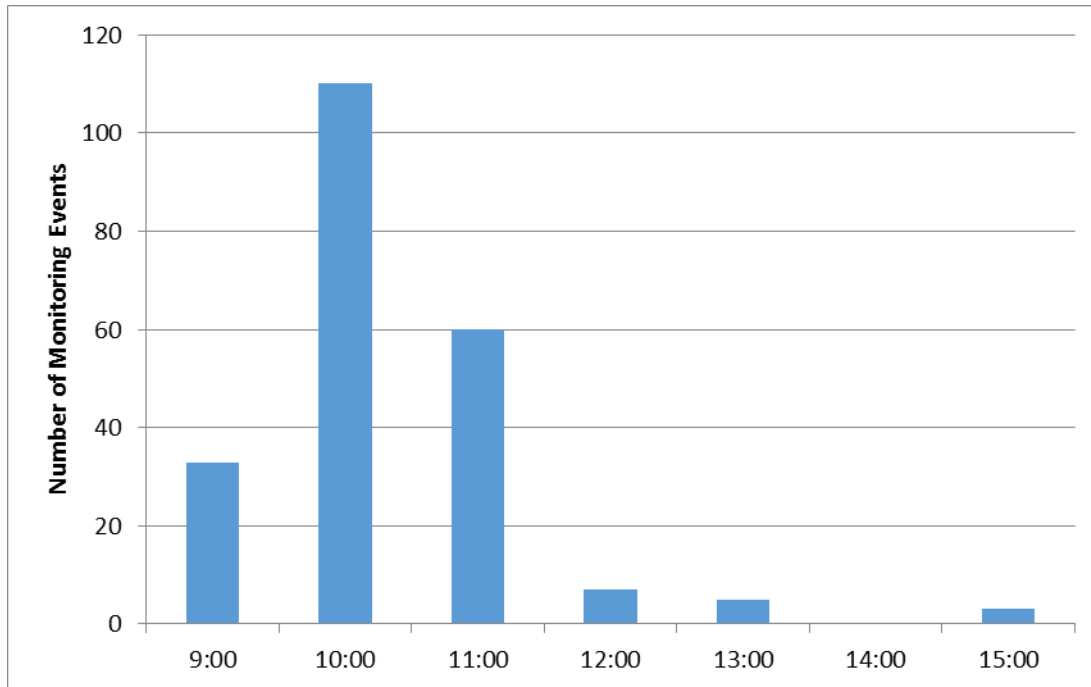
**Figure 4: Breakdown of time of monitoring in the White Rock Creek Watershed**

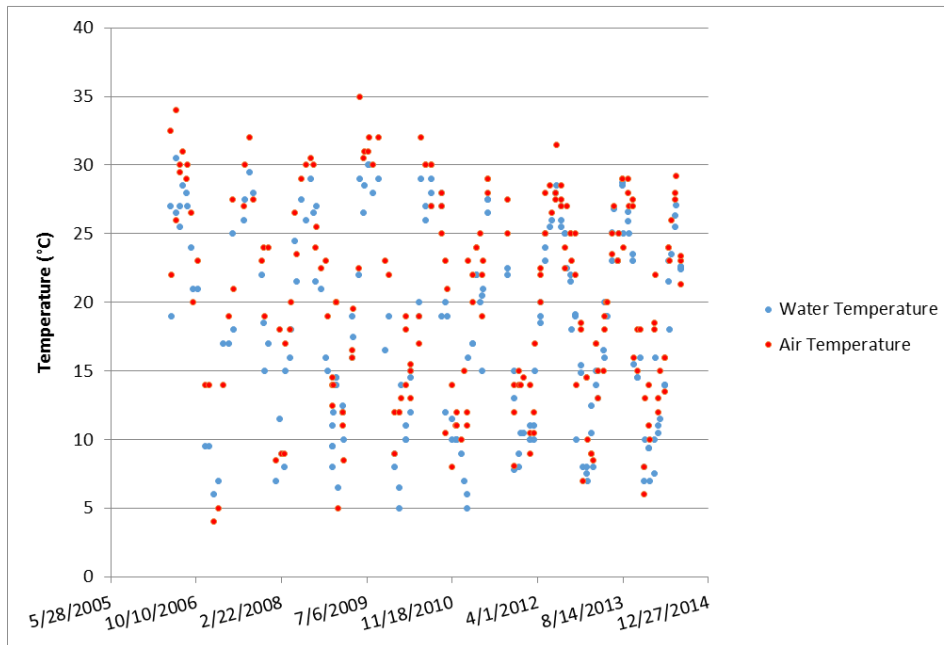
A total of 219 air and water temperatures were collected in the White Rock Creek Watershed between 2006 and 2014. Water temperatures never exceeded the TCEQ optimal temperature of 33.9 $^{\circ}$ C. Air temperature varied between 5 $^{\circ}$ C and 34 $^{\circ}$ C.

**Figure 5: Air and water temperature over time at all sites within the White Rock Creek Watershed**

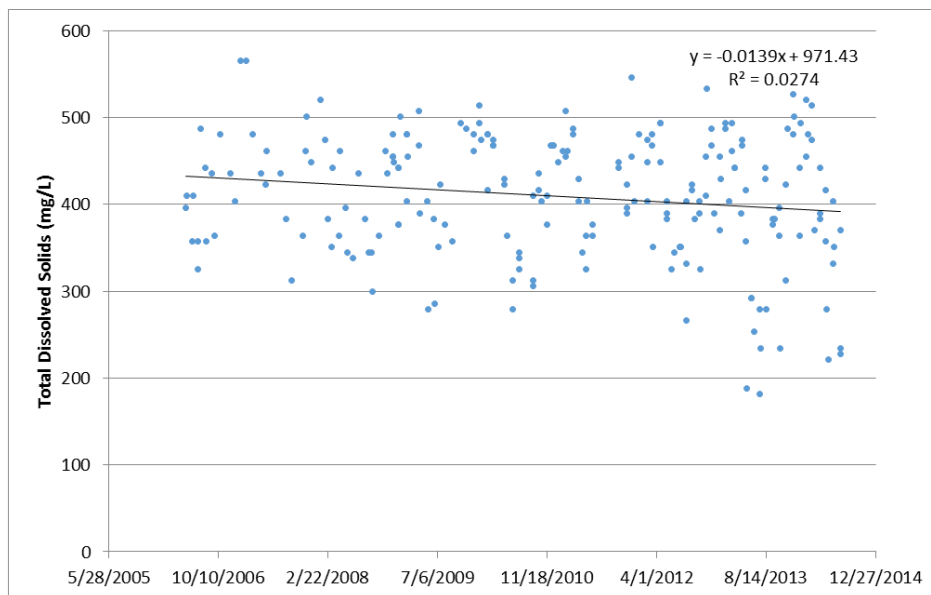
Citizen scientists conducted a total of 216 TDS measurements within the watershed. The TDS measurement was completed for 97.3% of all monitoring events. The average TDS measurement for all sites was 409 mg/L. There was a significant decreasing trend in total dissolved solids concentrations observed within the watershed for this time period ( $p = 0.015$ ). The low  $R^2$  value of 0.0274 indicates that this relationship only explains a small amount of the variation in the data.

**Figure 6: Total dissolved solids over time for all sites within the White Rock Creek Watershed**

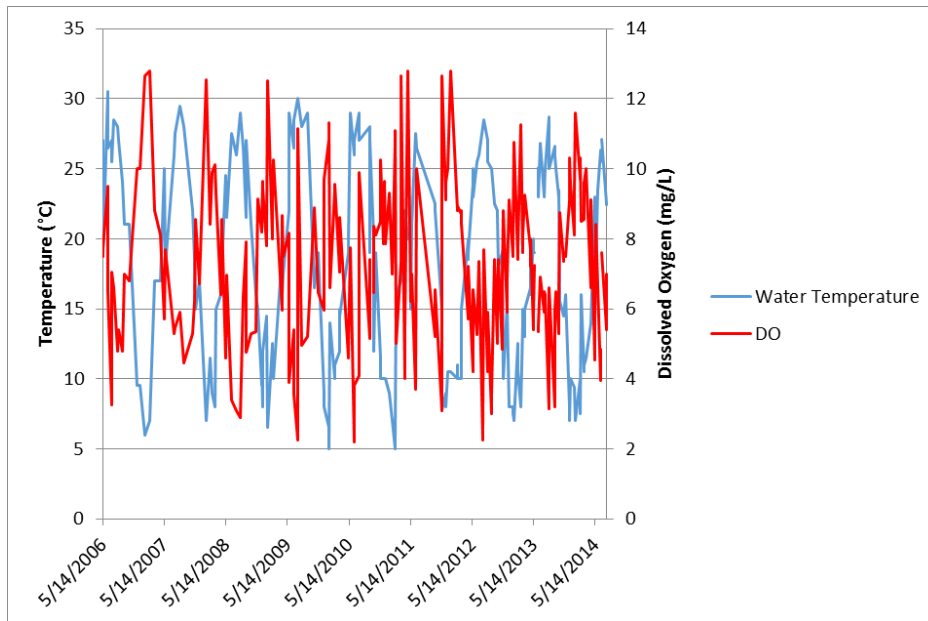
Citizen scientists collected 218 DO samples in the watershed during this time period. The mean DO concentration was 7.3 mg/L. Dissolved oxygen varied from a minimum of 2.2 mg/L in June of 2010, to a maximum of 12.8 mg/L in January of 2012. There was no significant trend in DO concentrations over time observed in this watershed.

**Figure 7: Water temperature and dissolved oxygen over time for all sites within the White Rock Creek Watershed**

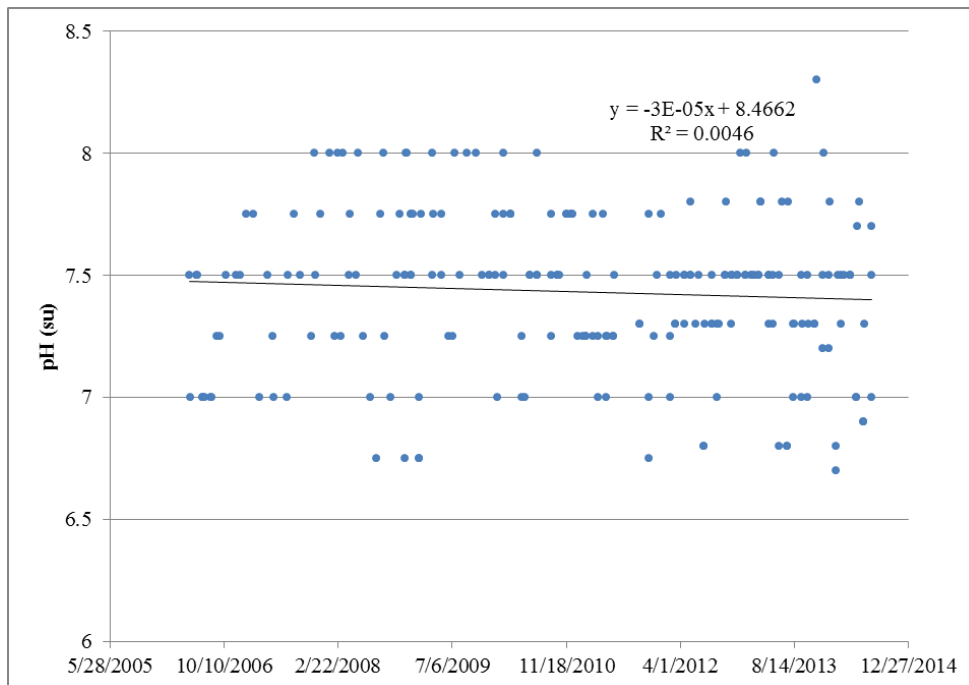
The pH was measured for 97.7% of all monitoring events in the watershed. The mean pH was 7.4 and it ranged from 6.7 to 8.3 for all sites. There was no significant trend in pH over time observed at this site.

Figure 8: pH for all sites within the White Rock Creek Watershed

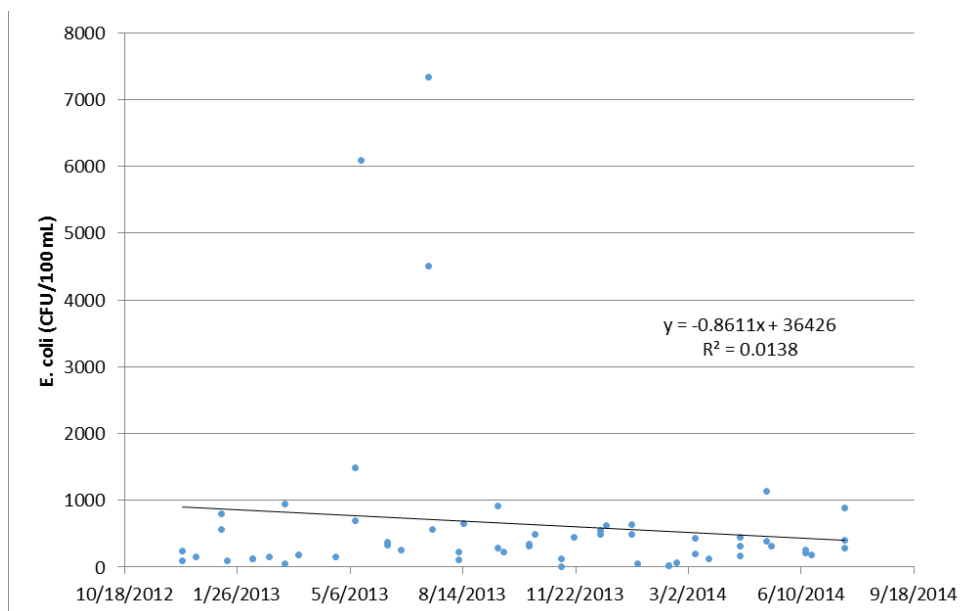
Citizen scientists collected 59 *E. coli* samples in this watershed. The geomean for *E. coli* was 276 CFU/100 mL for the watershed. *E. coli* counts ranged from 0 CFU/100 mL to 7,333 CFU/100 mL in July of 2013. There was no significant trend in *E. coli* over time observed at this site.

Figure 9: *E. coli* for all sites within the White Rock Creek Watershed

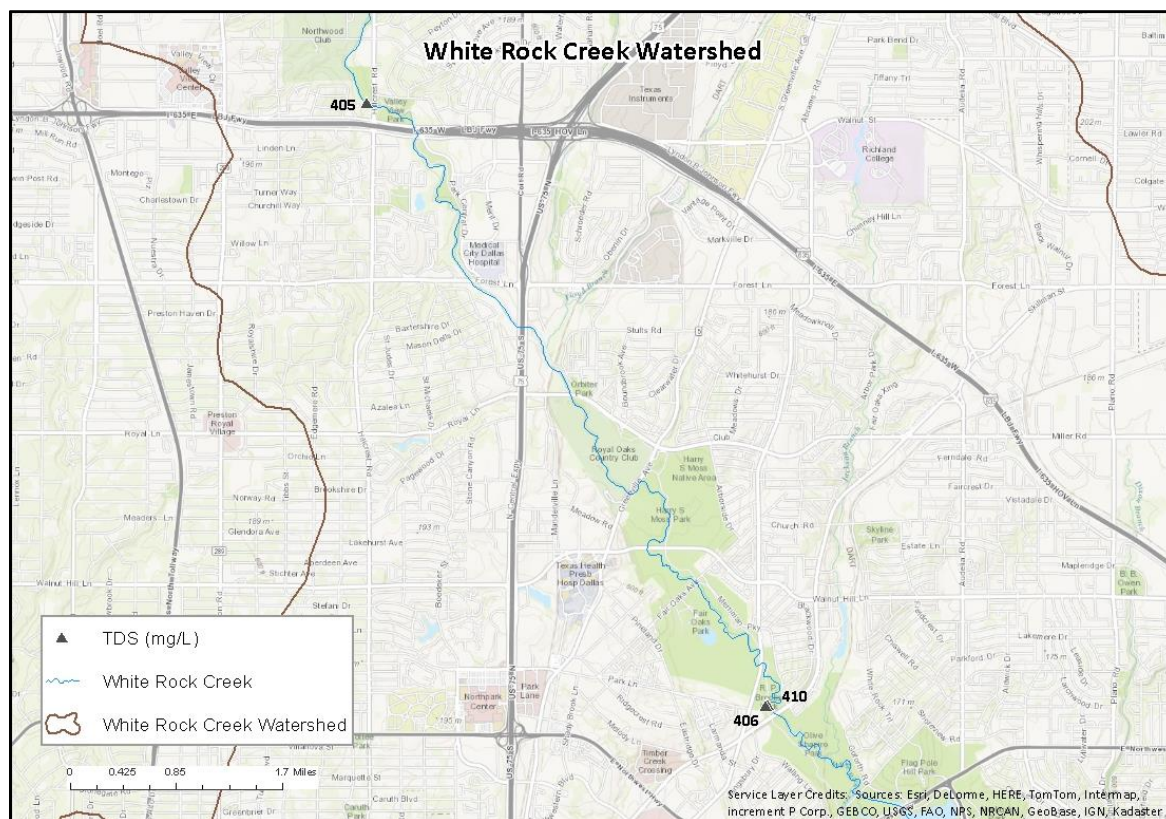
As previously mentioned in the 'Water Quality Parameters' section, TDS is an important indicator of turbidity and specific conductivity. The higher the TDS measurement, the more conductive the water is. A high TDS result can indicate increased nutrients present in the water. Site 80400 had the highest overall average for TDS, with a result of  $413 \pm 65$  mg/L. Site 80397 had the lowest average TDS, with a result of  $405 \pm 78$  mg/L.

Figure 10: Map of the average total dissolved solids for sites in the White Rock Creek Watershed

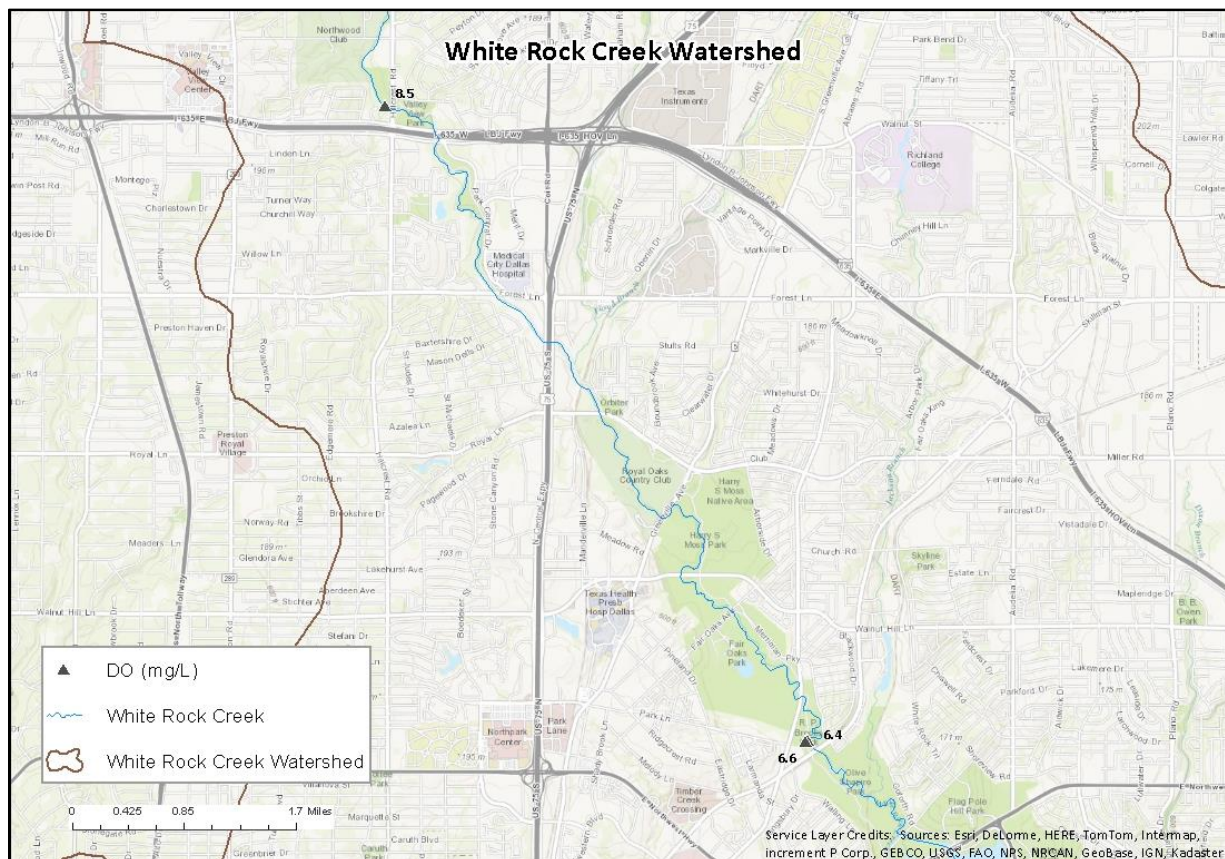
The DO measurement can help to understand the overall health of the aquatic community. If there is a large influx of nutrients into the water body than there will be an increase in surface vegetation growth, which can then reduce photosynthesis in the subsurface, thus decreasing the level of DO. Low DO can be dangerous for aquatic inhabitants, which rely upon the dissolved oxygen to breathe. The DO levels can also be impacted by temperature; a high temperature can limit the amount of oxygen solubility, which can also lead to a low DO measurement. Site 15280 had the lowest average DO reading, with a result of  $6.4 \pm 2.3$  mg/L. Site 80397 had the highest average DO reading, with a result of  $8.5 \pm 2.0$  mg/L.

**Figure 11: Map of the average dissolved oxygen for sites in the White Rock Creek Watershed**

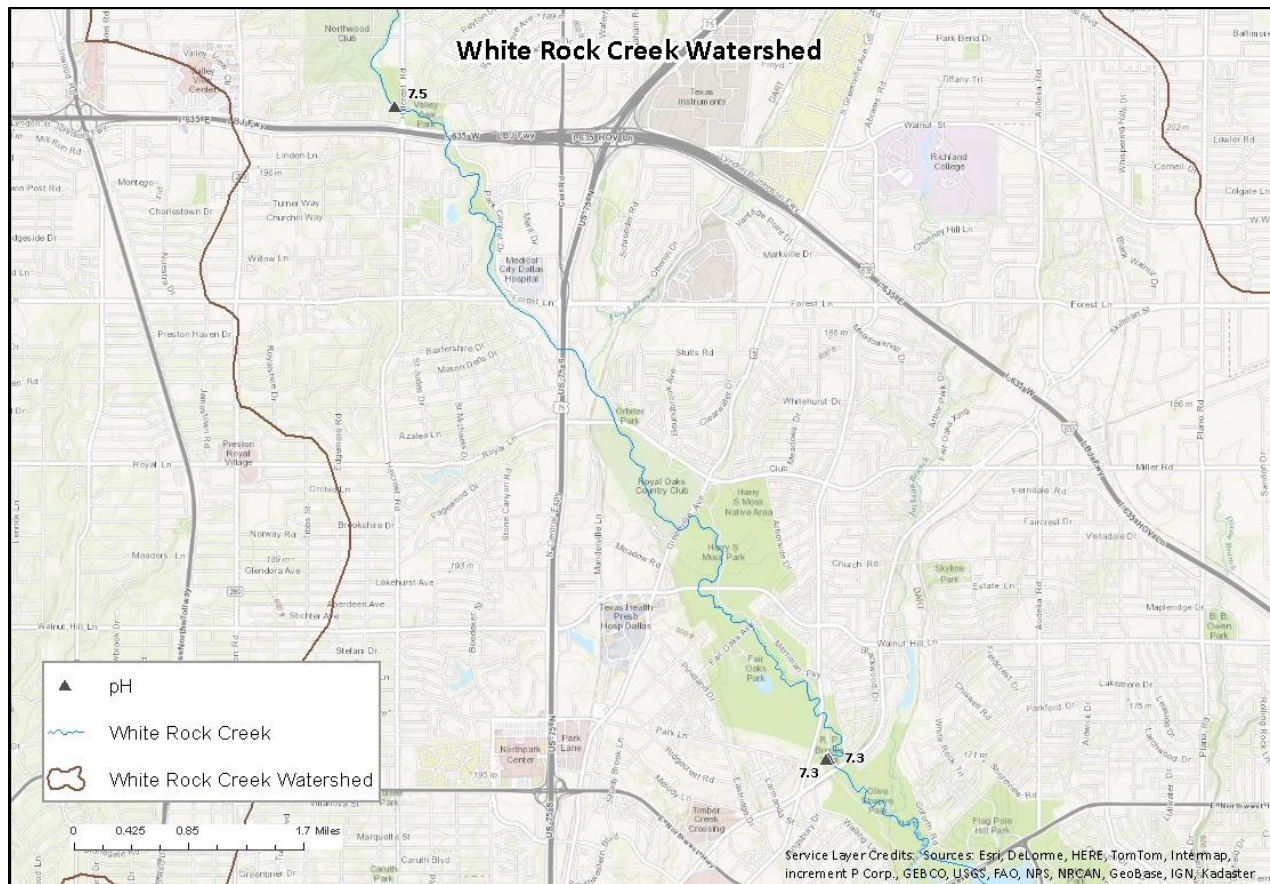
The pH levels are an important indicator for the overall health of the watershed as well. Aquatic inhabitants typically require a pH range between 6.5 and 9 for the most optimum environment. Anything below 6.5 or above 9 can negatively impact reproduction or can result in fish kills. There were no reported pH levels outside of this widely accepted range. Site 80397 had the highest average pH level, with a result of  $7.6 \pm 0.7$ . Sites 80400 and 15280 had the lowest average pH levels, with a result of  $7.3 \pm 0.3$  for both sites.

**Figure 12: Map of the average pH for sites in the White Rock Creek Watershed**

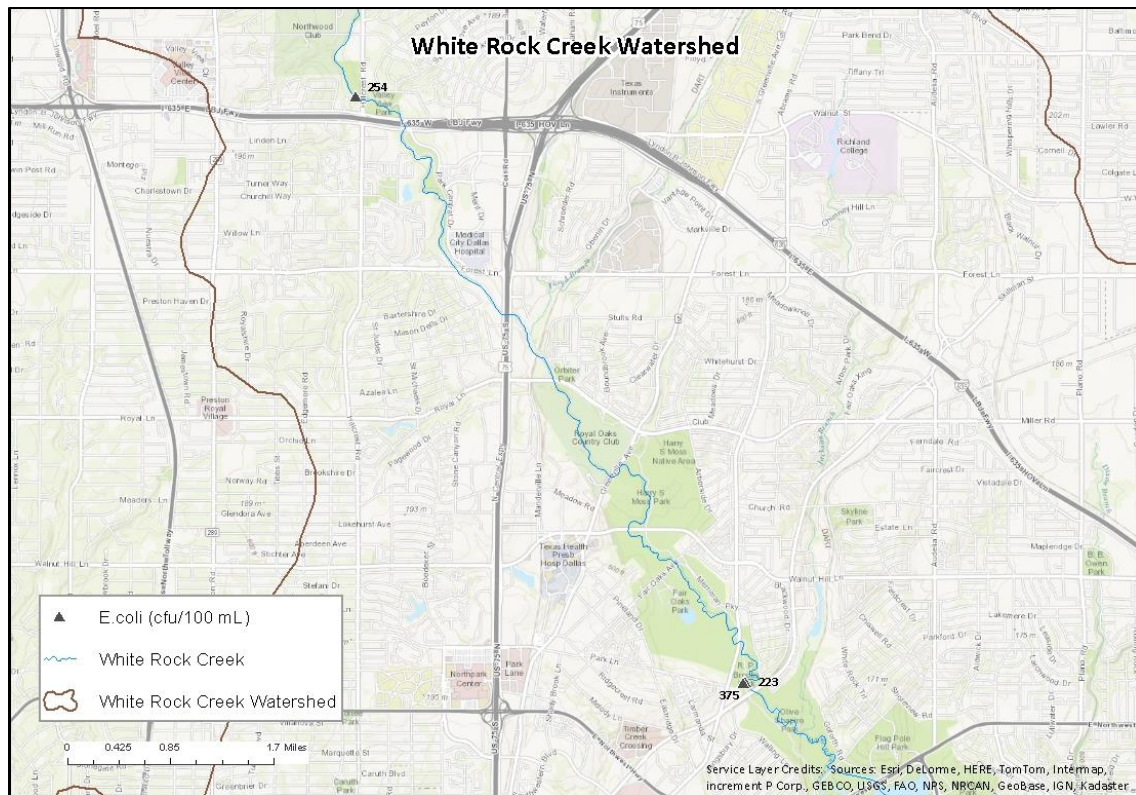
*E. coli* bacteria originate in the digestive tract of endothermic organisms. The EPA has determined *E. coli* to be the best indicator of the degree of pathogens in a water body, which are far too numerous to be tested for directly, considering the amount of water bodies tested. A pathogen is a biological agent that causes disease. The standard for *E. coli* impairment is based on the geometric mean (geomean) of the *E. coli* measurements taken. A geometric mean is a type of average which takes into account the high variability of parameters such as *E. coli* which can vary from zero to tens of thousands of CFU/100 mL. Site 80400 had the highest average geomean, with a result of 375 CFU/100mL. Site 15280 had the lowest average geomean, with a result of 223 CFU/100mL.

**Figure 13: Map of the geomean for E. coli for sites in the White Rock Creek Watershed**

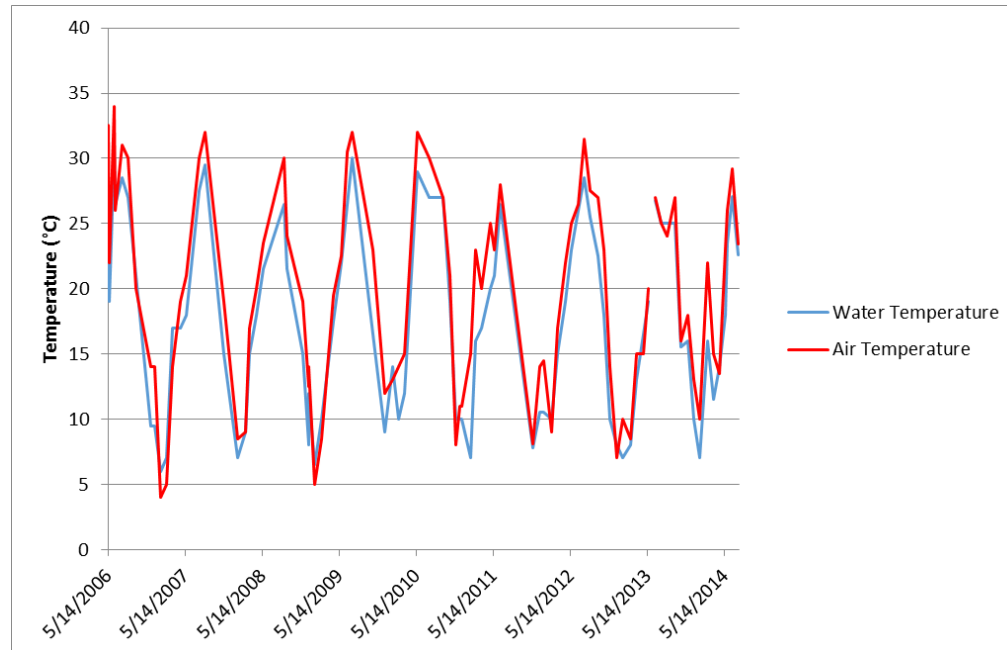
Citizen scientists collected 85 air and water temperatures at this site during this time. Air temperature varied from a low of 4°C in January of 2007, to a high of 34°C in June of 2006. The mean water temperature was 17.5°C. Water temperature ranged from a low of 6°C in January of 2007, to a high of 30.5°C in June of 2006.

**Figure 14: Air and water temperature at site 80397**

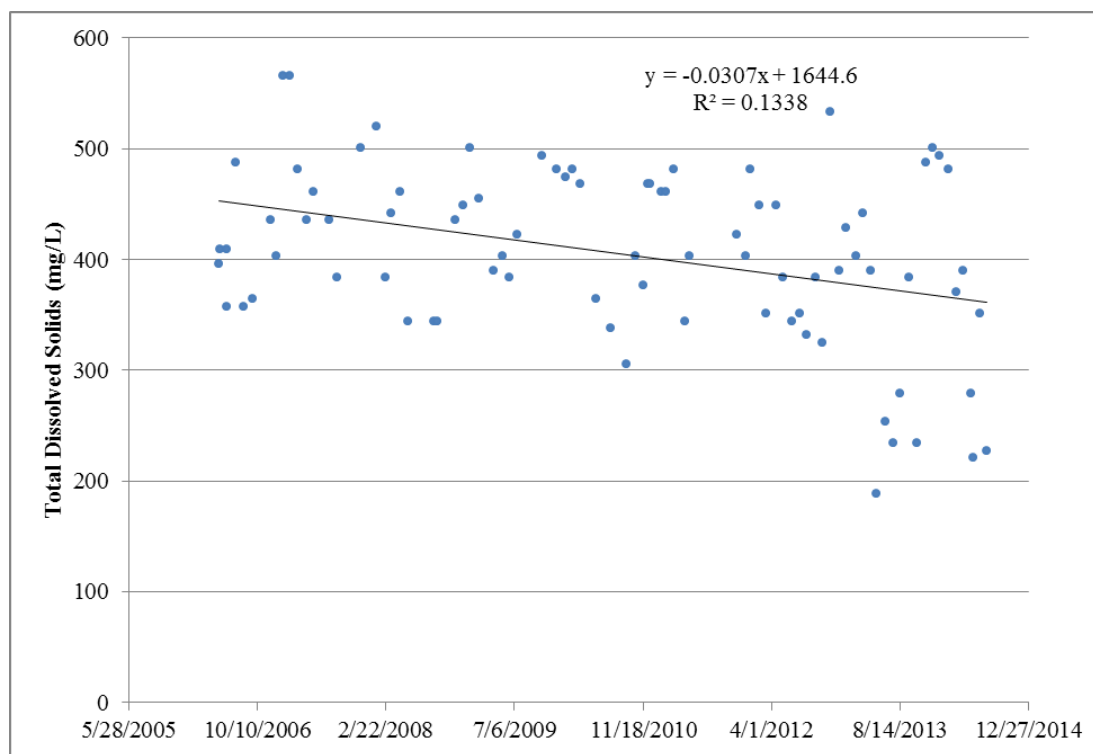
Citizen scientists recorded 83 TDS measurements at this site during this time. The mean TDS concentration was 405 mg/L. The minimum TDS concentration was 189 mg/L and was recorded in May,

2013. The maximum TDS concentration was 566 mg/L and was recorded in February of 2007. There was a significant decrease in TDS concentration over time observed at this site ( $p = 0.001$ ). The  $R^2$  value of 0.1338 indicates that this relationship explains about 13.4% of the variation in the data.

**Figure 15: Total dissolved solids at site 80397**

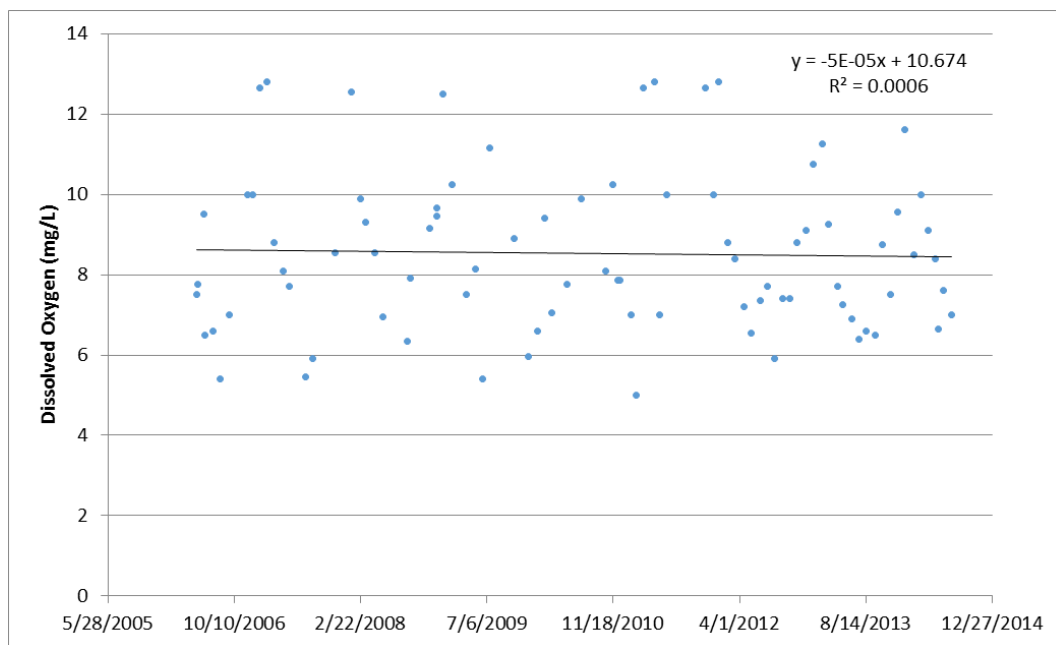
Citizen scientists collected 84 DO samples at this site. The mean DO concentration was 8.5 mg/L. The minimum DO concentration was 5.0 mg/L in February of 2011. The maximum DO concentration was 12.8 mg/L and was taken on several occasions. There was no significant trend in DO concentrations over time observed at this site.

Figure 16: Dissolved oxygen at site 80397

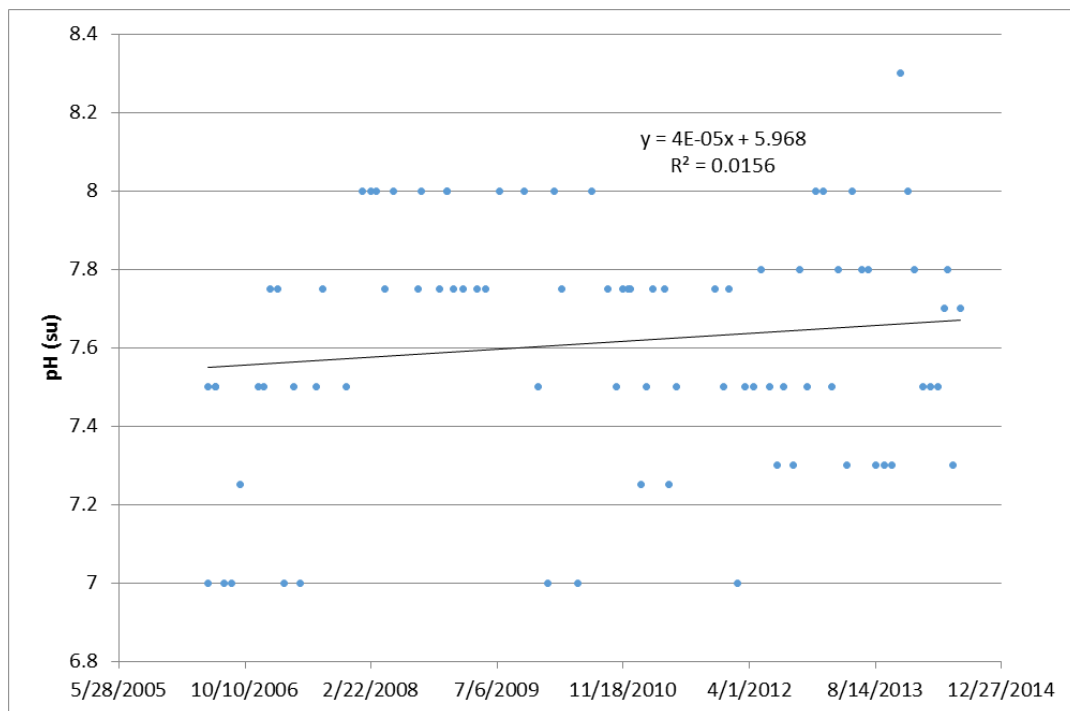
Citizen scientists collected 85 samples of pH at this site. The mean pH was 7.6 and it ranged from a low of 7.0, to a high of 8.3 in November, 2011. There was no significant trend in pH over time observed at this site.

Figure 17: pH at site 80397

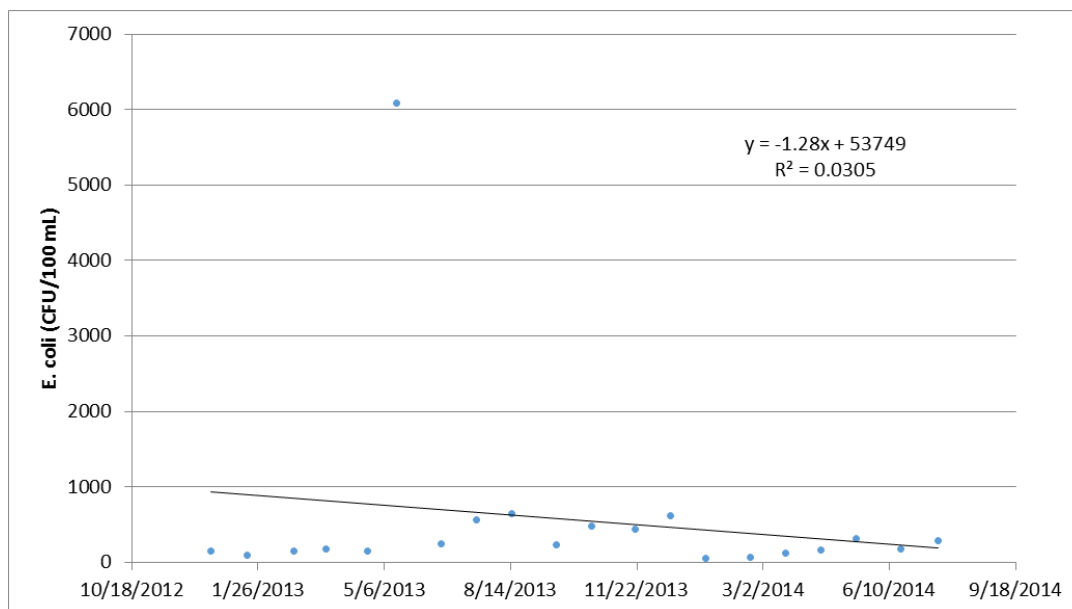
Citizen scientists collected 20 *E. coli* samples at this site. The geomean for *E. coli* was 254 CFU/100 mL. *E. coli* counts ranged from 50 CFU/100 mL in January of 2014, to a maximum of 6087 CFU/100 mL in May of 2013. There was no significant trend in *E. coli* over time observed.

Figure 18: *E. coli* at site 80397

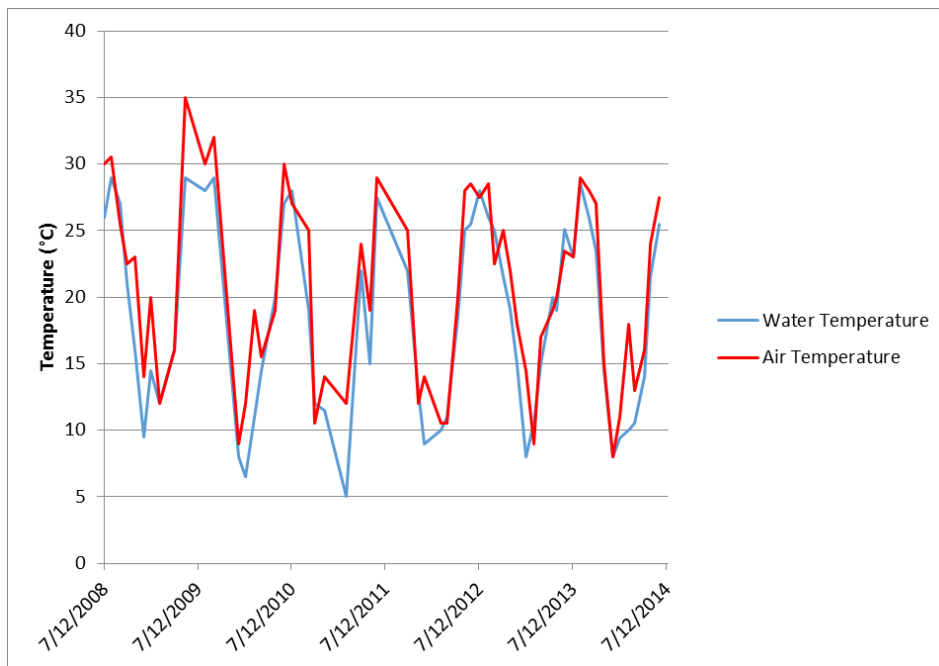
There were 59 air and water temperatures taken at this site. The air temperature ranged from a low of 8°C in December of 2013, to a high of 35°C in May of 2009. The mean water temperature was 18.4°C. The minimum water temperature was 5°C and was taken in February, 2011. The maximum water temperature was 29°C and was recorded 3 times in 2008 and 2009.

Figure 19: Air and water temperatures at site 80400

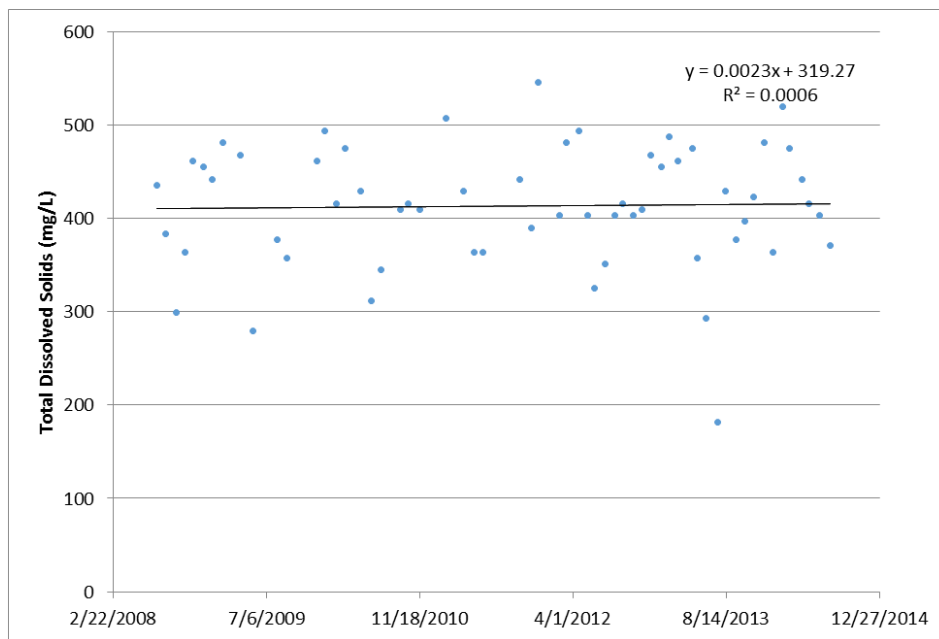
Citizen scientists took 59 TDS measurements at this site during this time. The mean TDS concentration was 413 mg/L. The minimum TDS concentration was 182 mg/L and was taken in July, 2013. The maximum TDS concentration was 546 mg/L and was taken in June of 2014. There was no significant trend in total dissolved solids over time observed at this site during this time.

Figure 20: Total Dissolved Solids at site 80400

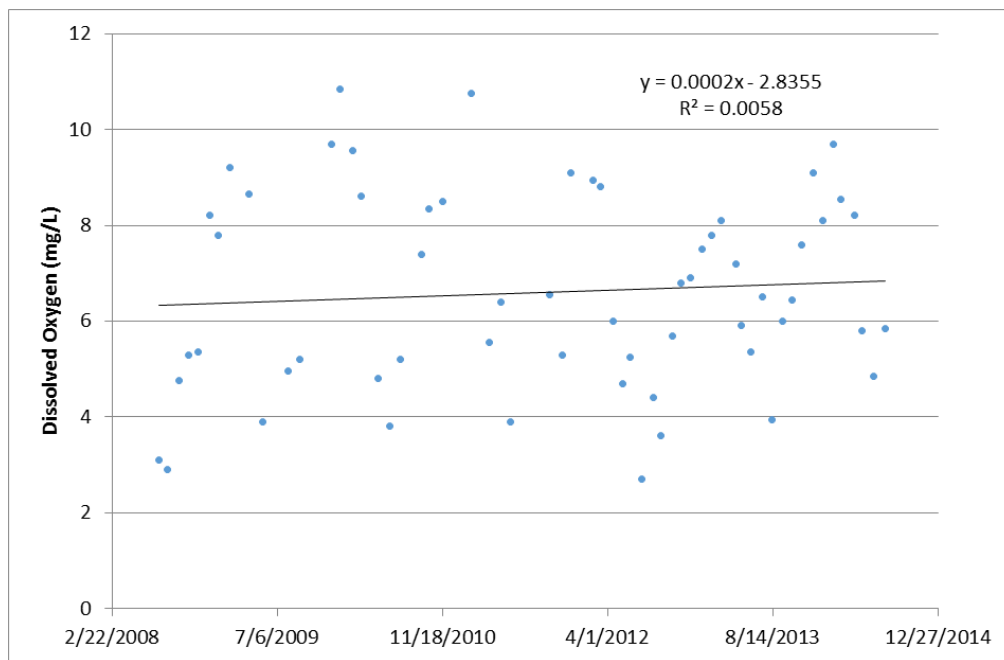
Citizen scientists collected 59 dissolved oxygen samples at this site during this time. The mean DO concentration was 6.6 mg/L. The minimum DO concentration was 2.7 mg/L and was recorded in July of 2012. The maximum DO concentration was 10.9 mg/L and was recorded in January of 2010. There was no significant trend in DO over time observed at this site.

Figure 21: Dissolved Oxygen at site 80400

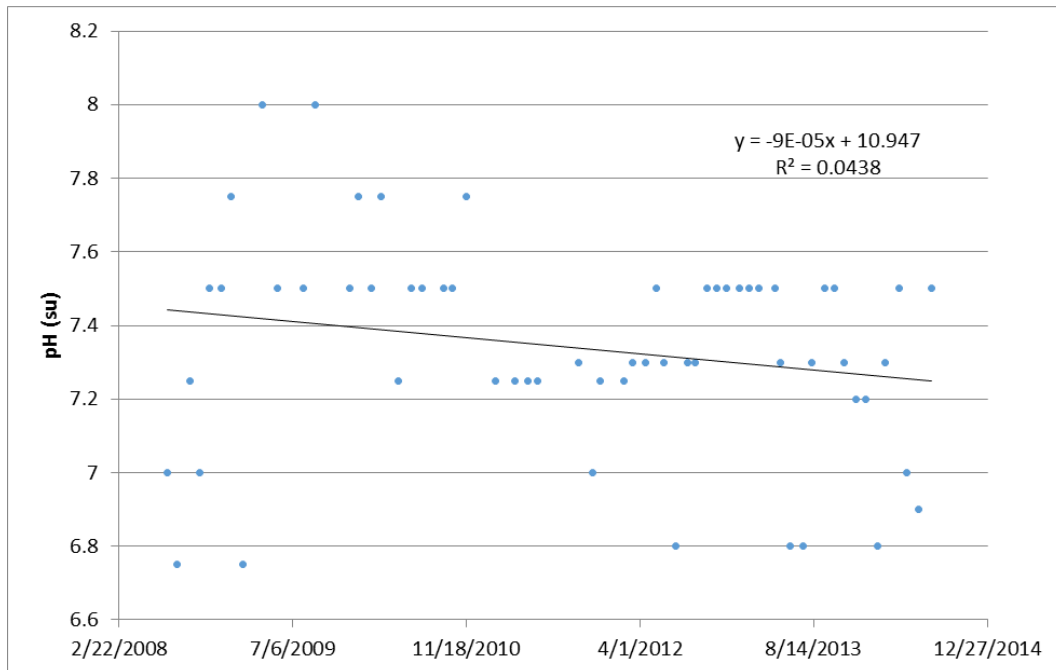
Citizen scientists took 59 pH measurements at this site during this time. The mean pH was 7.3 and it ranged from a low of 6.8 in August of 2008 and February of 2009, to a high of 8.0 in April and September of 2009. There was no significant trend in pH over time observed at this site.

**Figure 22: pH at site 80400**

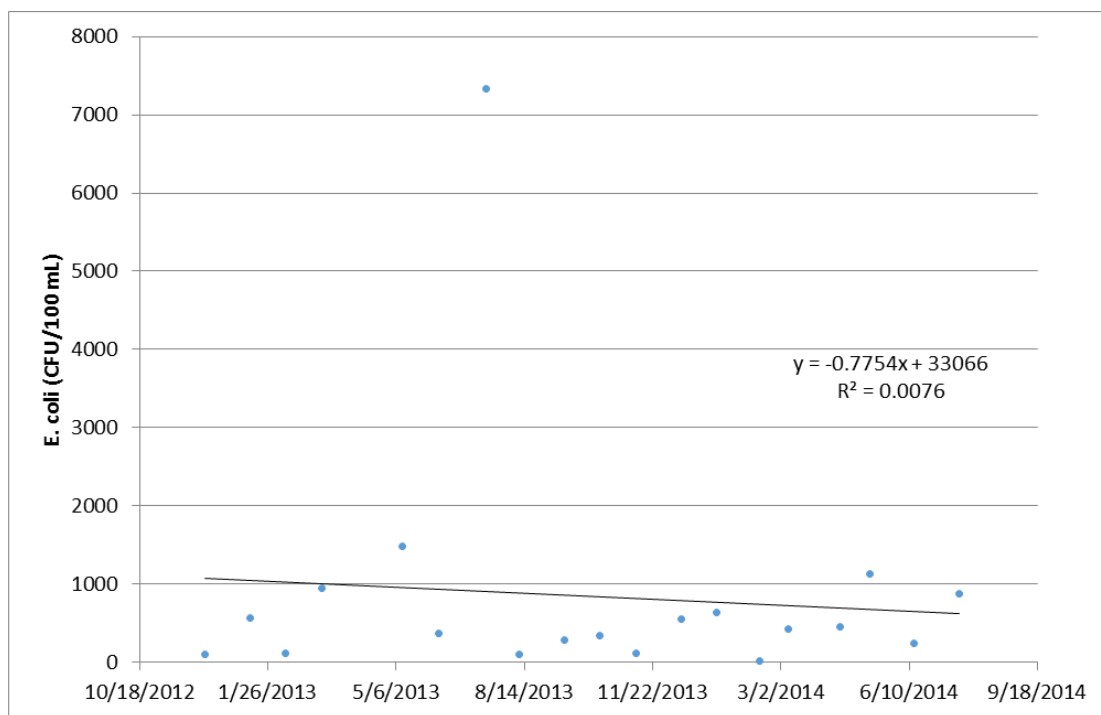
Citizen scientists collected 19 *E. coli* samples at this site. The geomean for *E. coli* was 375 CFU/100 mL. The *E. coli* varied from a minimum of 17 CFU/100 mL in February of 2014, to a maximum of 7333/100 mL in July of 2013. There was no significant trend in *E. coli* over time observed at this site.

Figure 23: E. coli at site 80400

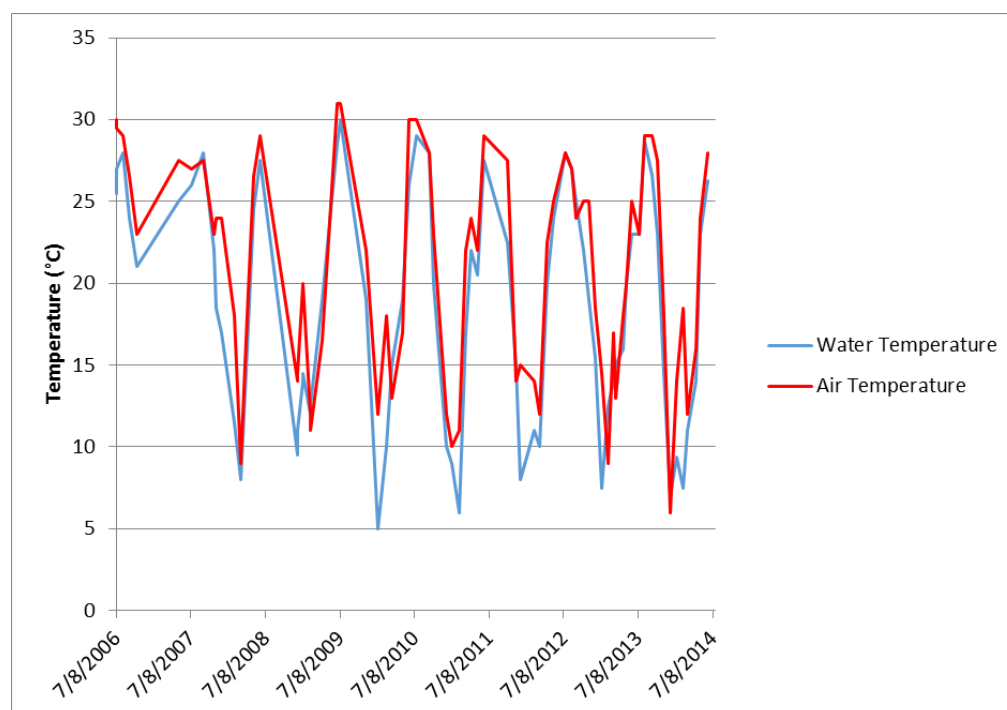
There were 75 air and water temperatures taken at this site during this time. The air temperature varied from a low of 6°C in December of 2013, to a high of 31°C in July, 2009. The mean water temperature was 18.5°C. Water temperature ranged from a low of 5°C in January, 2010 to a high of 30°C in July of 2009.

**Figure 24: Air and water temperatures at Site 15280**

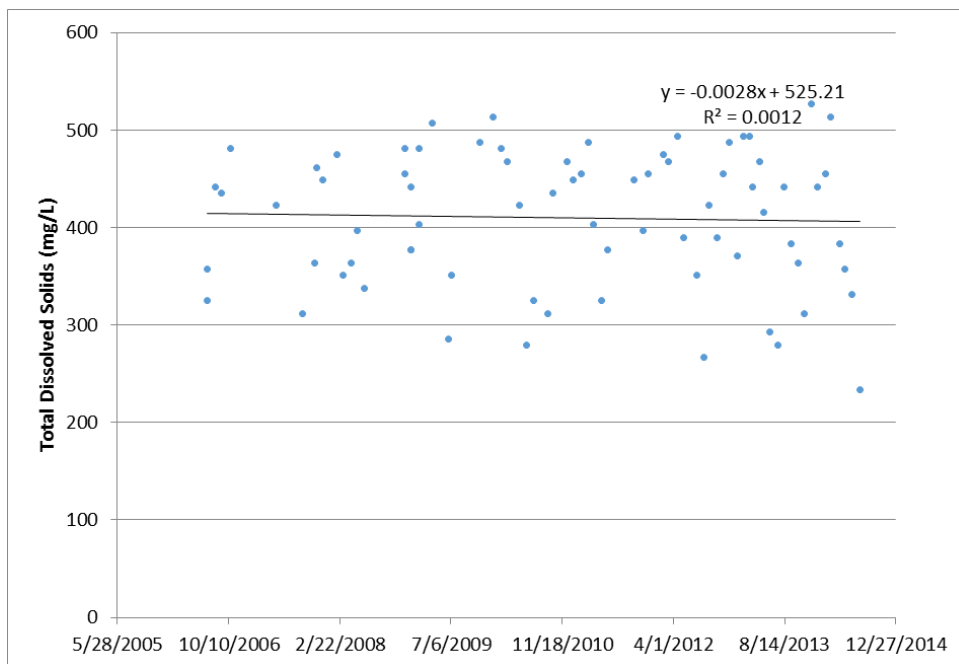
Citizen scientists took 74 TDS measurements at this site. The mean TDS concentration was 410 mg/L. The minimum TDS concentration was taken in July of 2014 and was 234 mg/L. The maximum TDS concentration was 527 mg/L and was taken in December of 2013. There was no significant trend in TDS concentration over time observed at this site.

Figure 25: Total dissolved solids at Site 15280

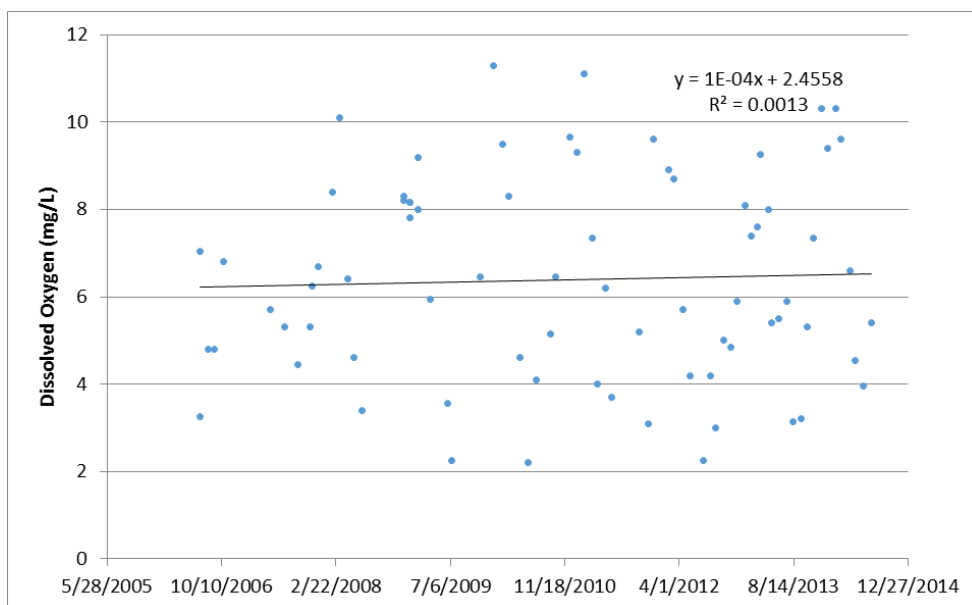
Citizen scientists collected 75 dissolved oxygen samples at this site during this time. The mean DO concentration was 6.4 mg/L. DO concentration ranged from a low of 2.2 mg/L in June of 2010, to a high of 11.3 mg/L in January of 2010. There was no significant trend in DO over time observed at this site.

Figure 26: Dissolved oxygen at Site 15280

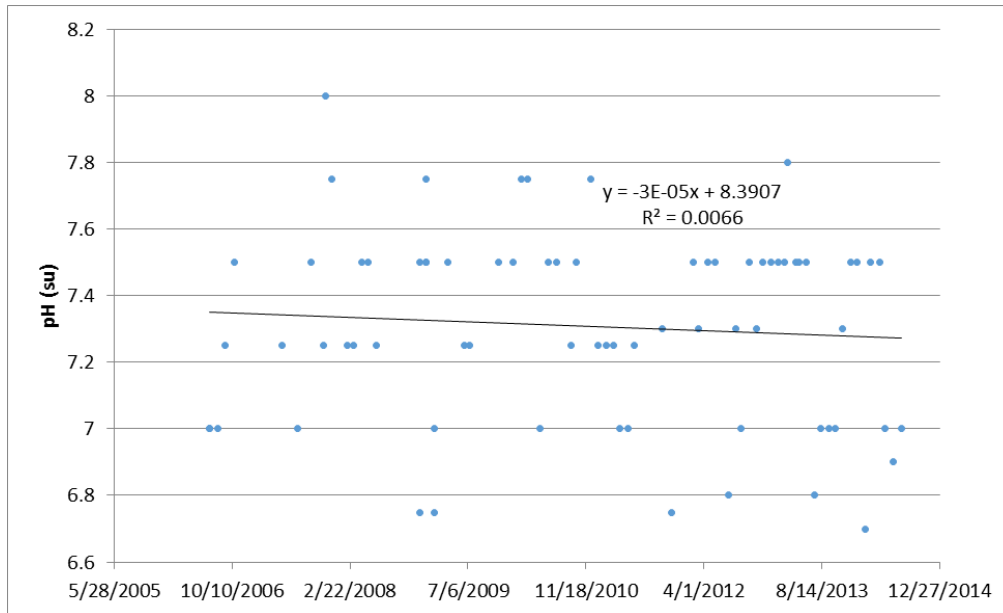
There were 74 pH measurements taken at this site during this time. The mean pH was 7.3 and it ranged from a minimum of 6.7 in February of 2014 to a maximum of 8.0 in November of 2007. There was no significant trend in pH over time observed at this site.

Figure 27: Dissolved oxygen at Site 15280
