# White Rock Creek Watershed Data Report

August 2014

**THE MEADOWS CENTER**  
FOR WATER AND THE ENVIRONMENT

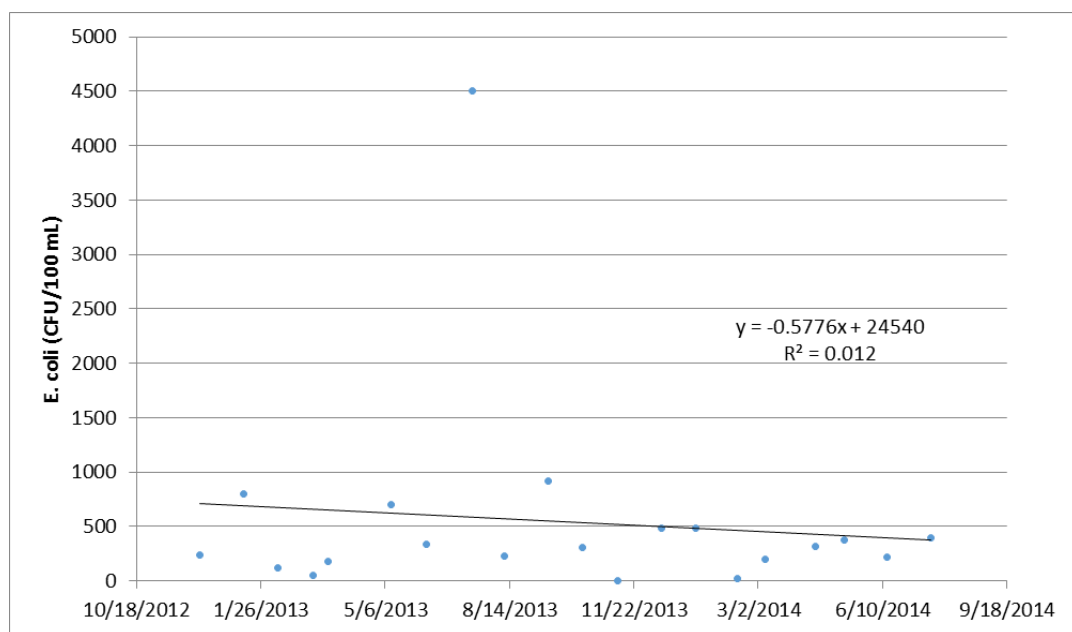
Citizen scientists collected 20 *E. coli* samples at this site. The geomean for *E. coli* was 223 CFU/100 mL. *E. coli* ranged from 0 CFU/100 mL in November of 2013 to 4500 CFU/100 mL in July of 2013. There was no significant trend in *E. coli* observed at this site.

**Figure 28: E. coli at Site 15280**
