Contract Report 23-002

Little Blanco River Occurrence of Flowing Water Central Texas Hill Country, USA

February 2023

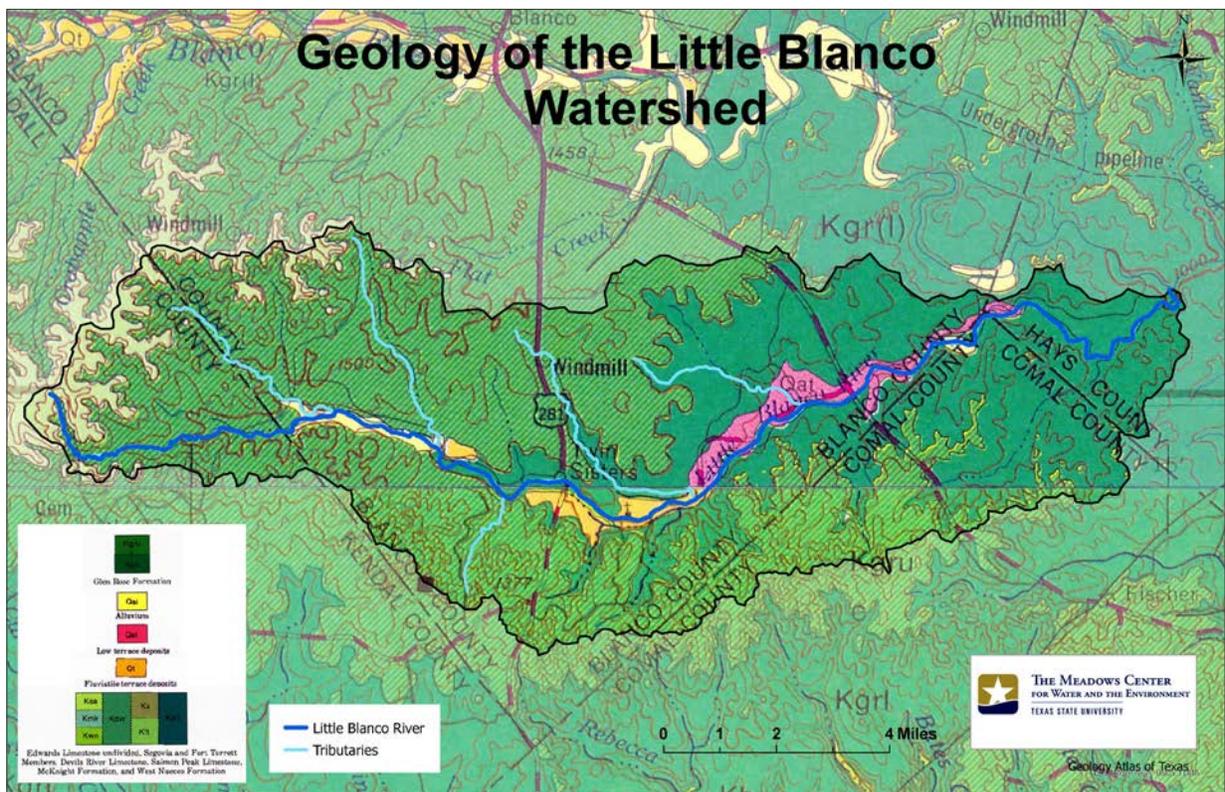
FIGURE 8. GEOLOGY OF THE LITTLE BLANCO SUBWATERSHED

The Little Blanco River watershed is underlain by gently east to southeast dipping Cretaceous age carbonate rock units (Figure 8). The upper most surficial rock unit is the Edwards Limestone and is present on hilltops on the far western edge of the watershed. Underlying the Edwards Limestone is the Glen Rose formation. Except where remnants of the Edwards are present on hilltops, the Glen Rose formation is the surficial rock unit present throughout the watershed. The Glen Rose formation consists of two members: the Upper and Lower Glen Rose formations. The Upper Glen Rose is present in the higher elevations in the western half of the watershed, generally west of Highway 281. The Upper Glen Rose consists of thin to medium-bedded limestone and dolomite. In the eastern part of the watershed, the Upper Glen Rose has been eroded to expose the Lower Glen Rose member. The Lower Glen Rose can exhibit extensive karst development. The Hensel and Cow Creek formations underlie the Glen Rose Formation (Figure 9). The Hammett Shale separates the Cow Creek from the underlying Sligo and Hosston Formations (Wierman, 2010).

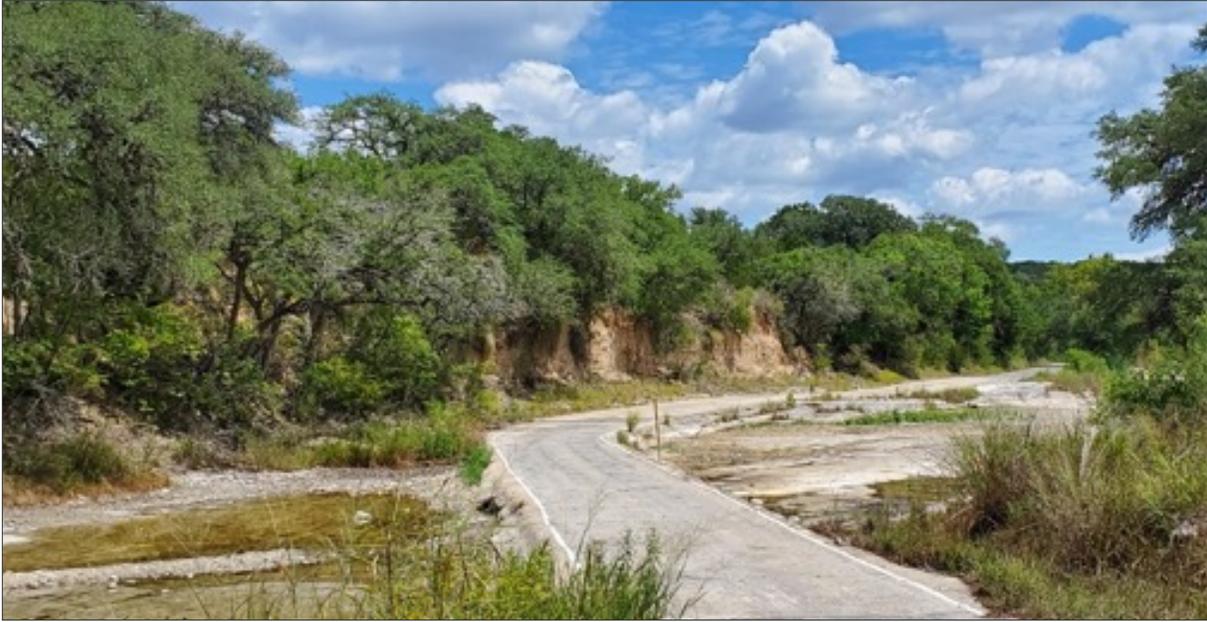
FIGURE 10. ALLUVIAL DEPOSITS OVERLYING LOWER GLEN ROSE, WEST OF HWY 281 ON LITTLE BLANCO ROAD

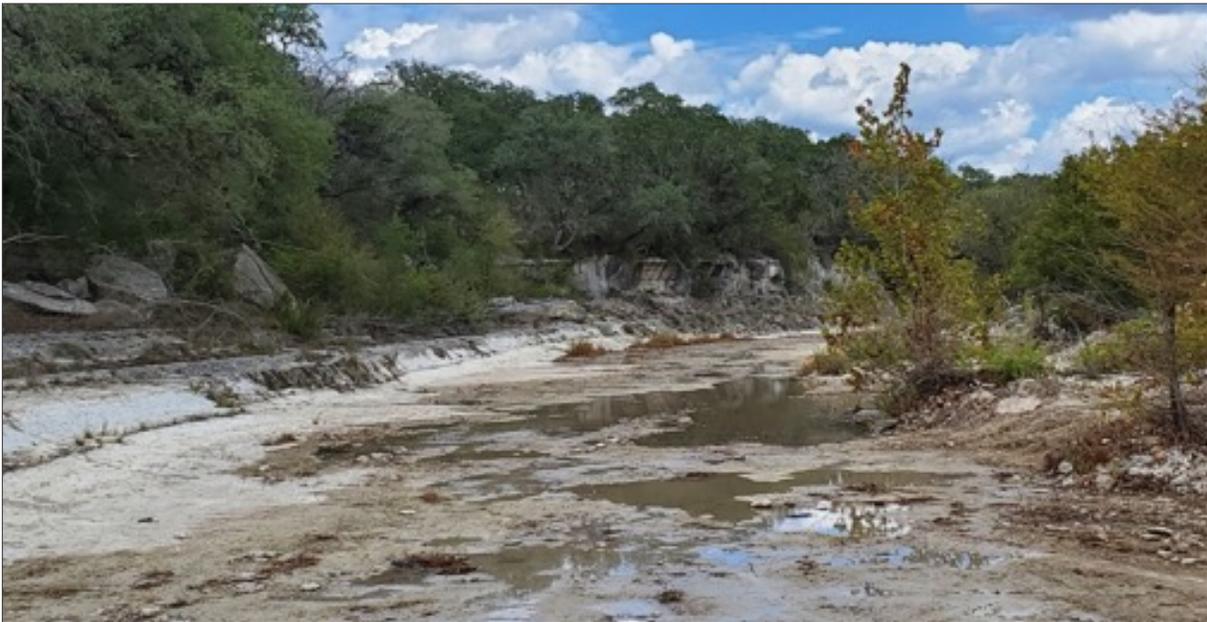
FIGURE 11. LOWER GLEN ROSE FORMING FLAT RIVER BOTTOM, WEST OF HWY 281 ON LITTLE BLANCO ROAD

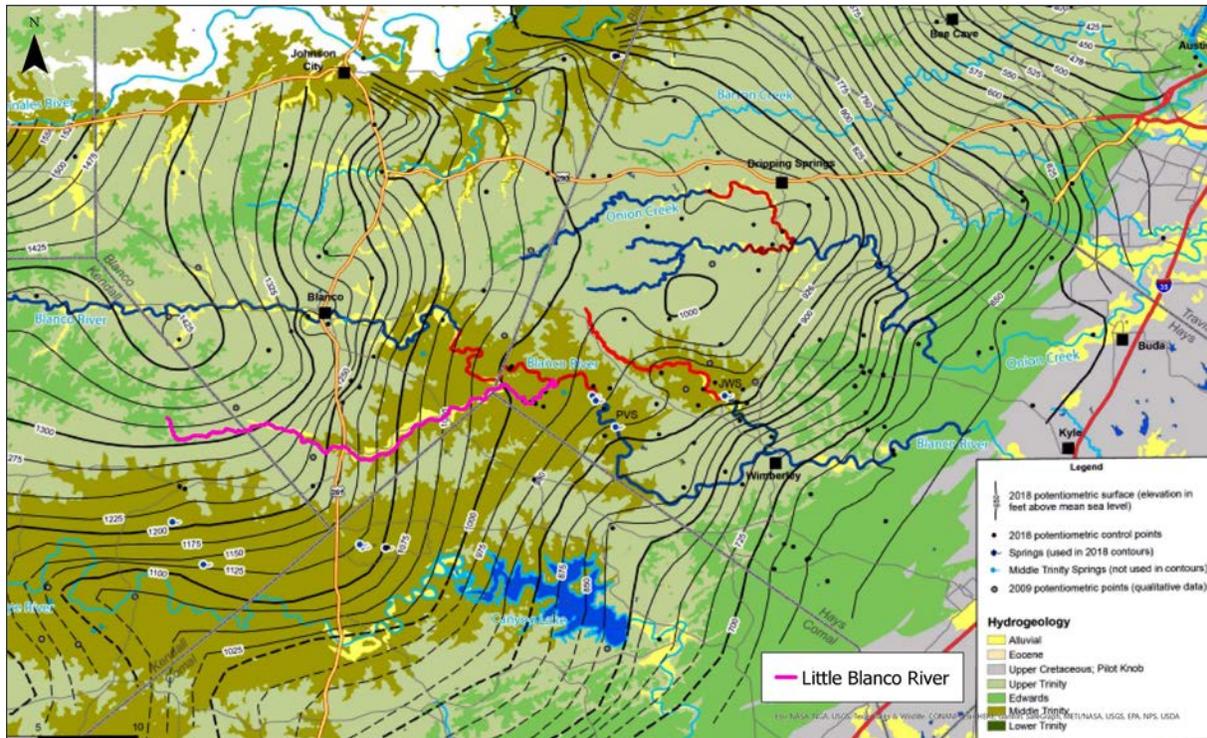
FIGURE 12. POTENTIOMETRIC SURFACE MAP OF THE MIDDLE TRINITY AQUIFER (AFTER HUNT, 2019)

Due to the limited number of wells available for measurements included in this study, watershed wide groundwater flow directions were not determined. Several regional studies, as summarized in Hunt (2019), indicate groundwater flow direction in the Middle Trinity to be to the east-southeast (Figure 12).

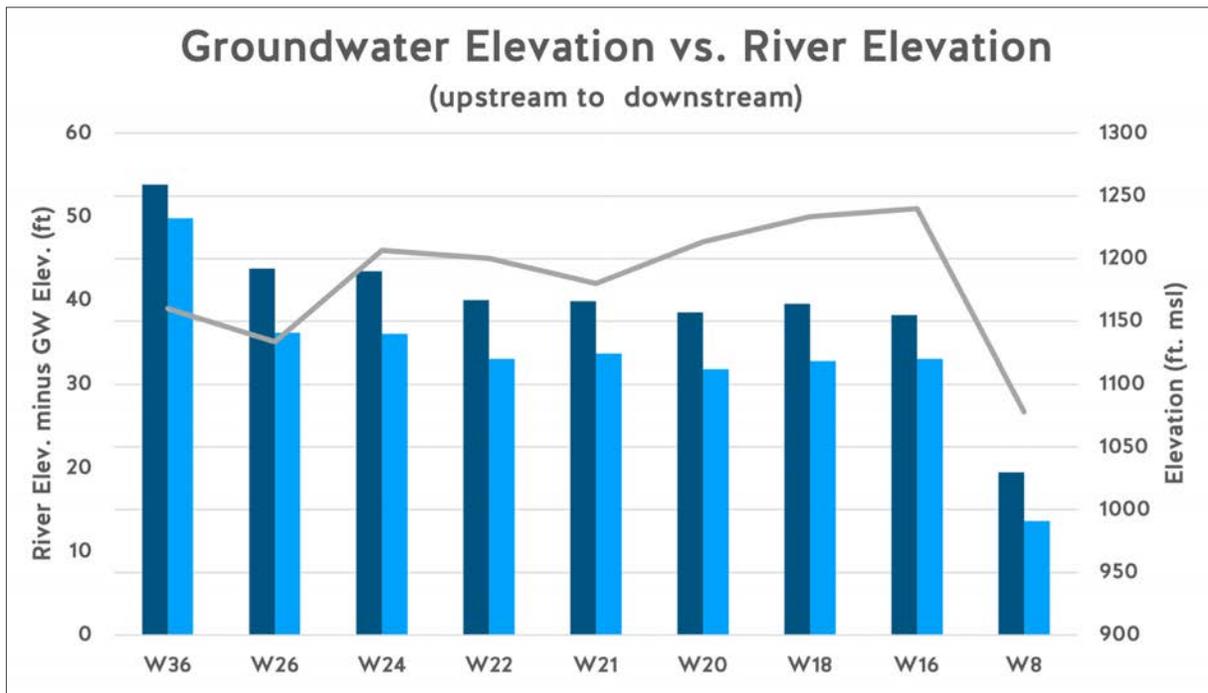
FIGURE 14. GROUNDWATER ELEVATION VS. RIVER ELEVATION

Depth to water from the ground surface measured at wells monitored during this study (Figure 14) generally ranged from 50 to 100 feet (Figure 15). The wells were selected for monitoring based on accessibility and close proximity to the river. Well logs were not available for any of the wells but based on regional information, it is believed that all the wells were completed in the Middle Trinity aquifer, either in the Lower Glen Rose or Hensel/Cow Creek. Groundwater elevations were below the base of the river in all locations during the study. Groundwater levels near the river that are above the base of the river would be indicative of groundwater discharge to the river, or a gaining river condition. If groundwater levels are below the base of the river, this would indicate a river losing condition. Though it appears that all groundwater river levels were below the base of the river during this study, drought conditions developed causing water levels to drop below the river whereas in wetter conditions, the levels would be higher.

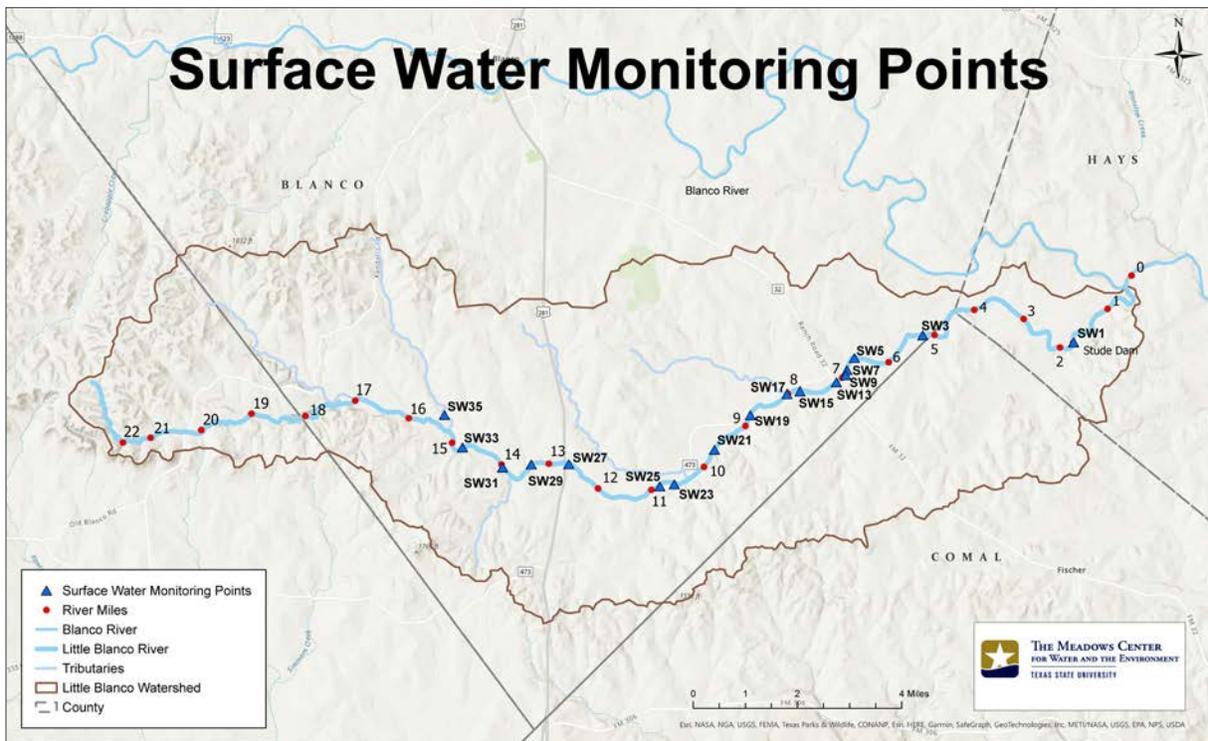
FIGURE 17. RIVER MILES AND SURFACE WATER MONITORING POINTS

There is a major spring and pools in the river at SW1 (Figure 17). The spring originates from a cliff of the Lower Glen Rose. The river flows a short distance (0.3 mile) where it is lost to the subsurface. The river has a few isolated downstream pools towards the confluence with the Blanco River.

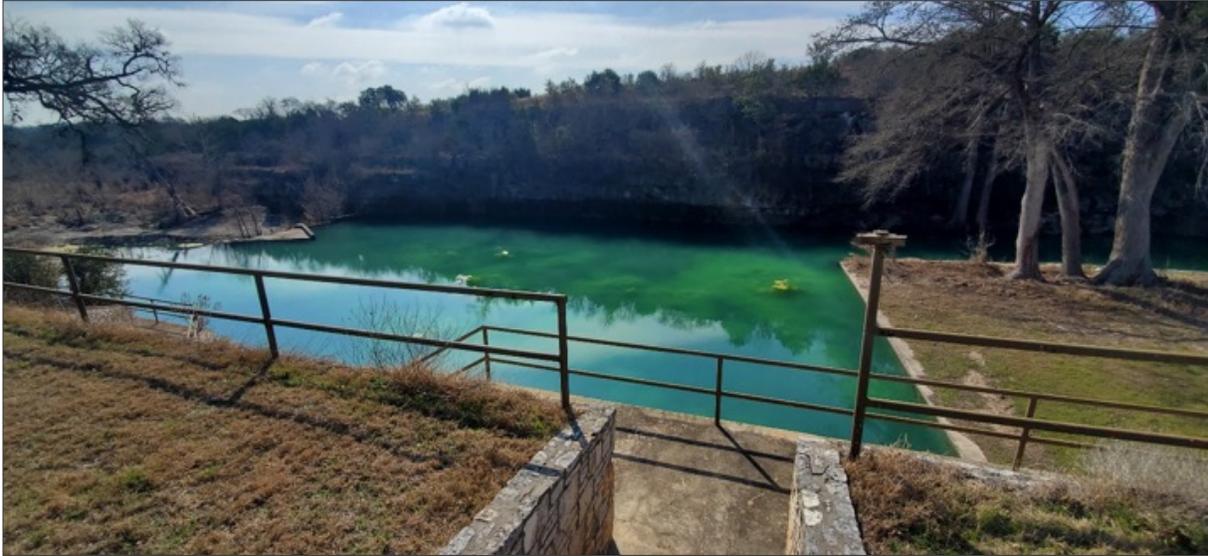
FIGURE 18. SITE 1: POOL BENEATH LOWER GLEN ROSE IN HAYS COUNTY

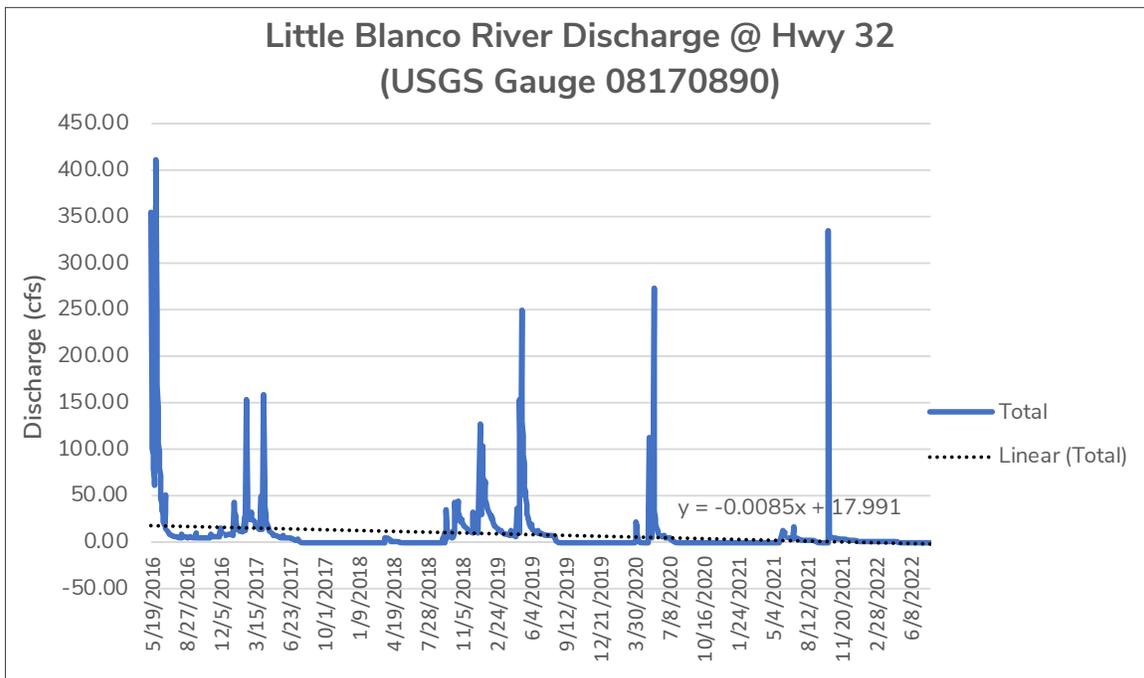
FIGURE 19. LITTLE BLANCO RIVER DISCHARGE AT HIGHWAY 32

There were periods of no flow at the gauge site in 2017, 2018, and 2022. Low flows of less than 0.5 cfs were measured in 2019 and 2021. A linear trend line is shown in Figure 19. The overall discharge trend is downward but, due to the short period record and “flashy” nature of flow, it is not clear if this represents a short-term cycle or a longer trend.

The mean daily discharge for the period of record is 8.2 cubic feet per second (cfs) with a median discharge of 1.2 cfs. The linear trend of the discharge data is downward from 2006 – 2019. Flow percentiles from the discharge data were calculated and shown in Figure 20.

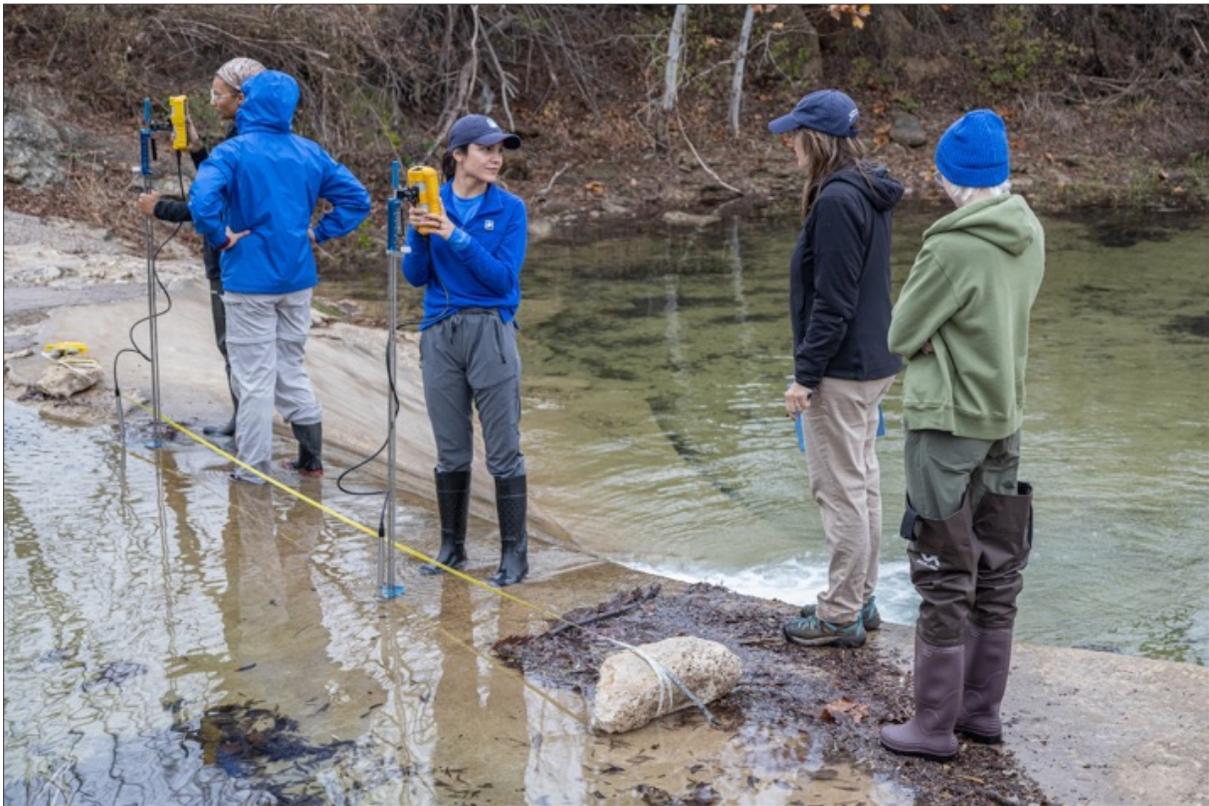
FIGURE 22. MEADOWS CENTER STAFF RECORDS FLOW WITH THE FLOWTRACKER (PHOTO CREDIT: ANDREW SHIREY)

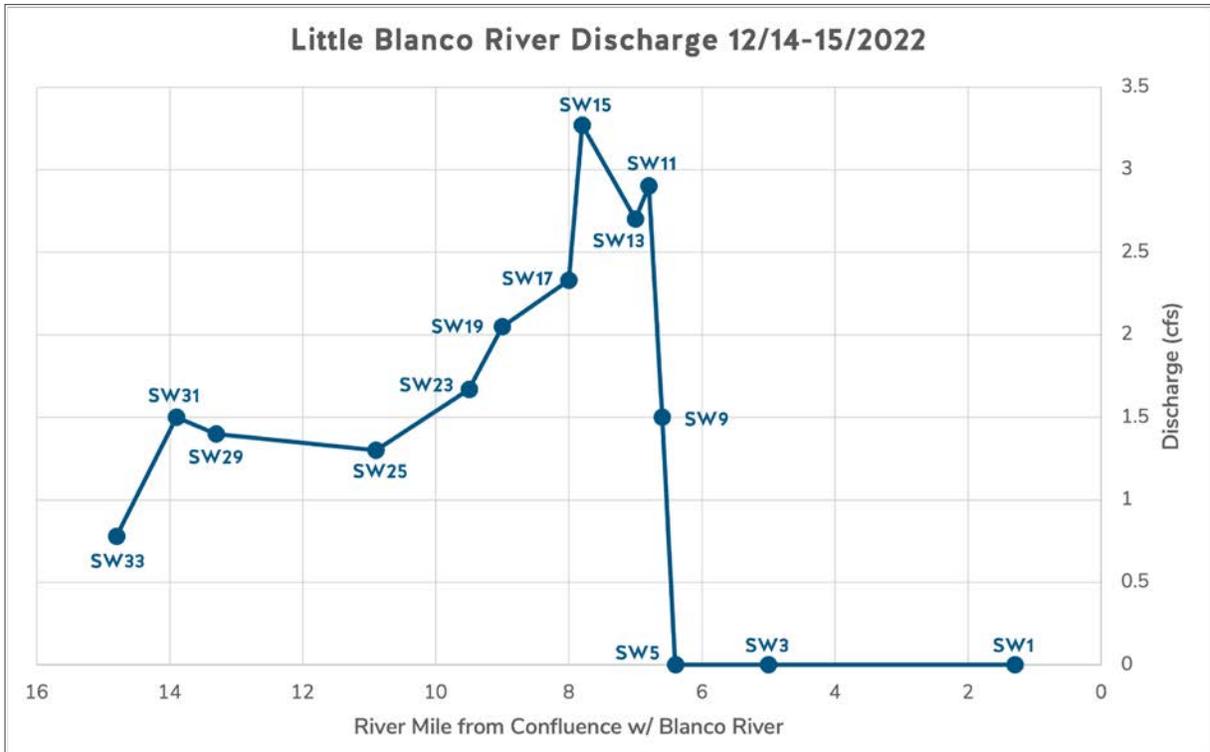
FIGURE 23. LITTLE BLANCO RIVER DISCHARGE, DECEMBER 2022

A synoptic surface water gauging event took place on December 14-15, 2021 to measure base flow in the Little Blanco River (Table 4 and Figure 23). Base flow is key to maintaining flow in the stream to maintain its ecologic health and value to local landowners. Flow measurements were made using a SonTek FlowTracker2 handheld Acoustic Doppler Velocimeter® generally following USGS protocols. River miles from the confluence of the Little Blanco River and the Blanco River were determined using GIS techniques (Figure 16).

Flow measurements were made at thirteen sites and estimated at another site (Schuetz Creek). Other sites of no flow were observed and noted. The results of the event are shown on Table 4, Figure 23, and Figure 25. As previously mentioned, access to the river was not available so the actual headwaters were not determined, but air photo research indicates the headwaters are near the confluence with Schuetz Creek.

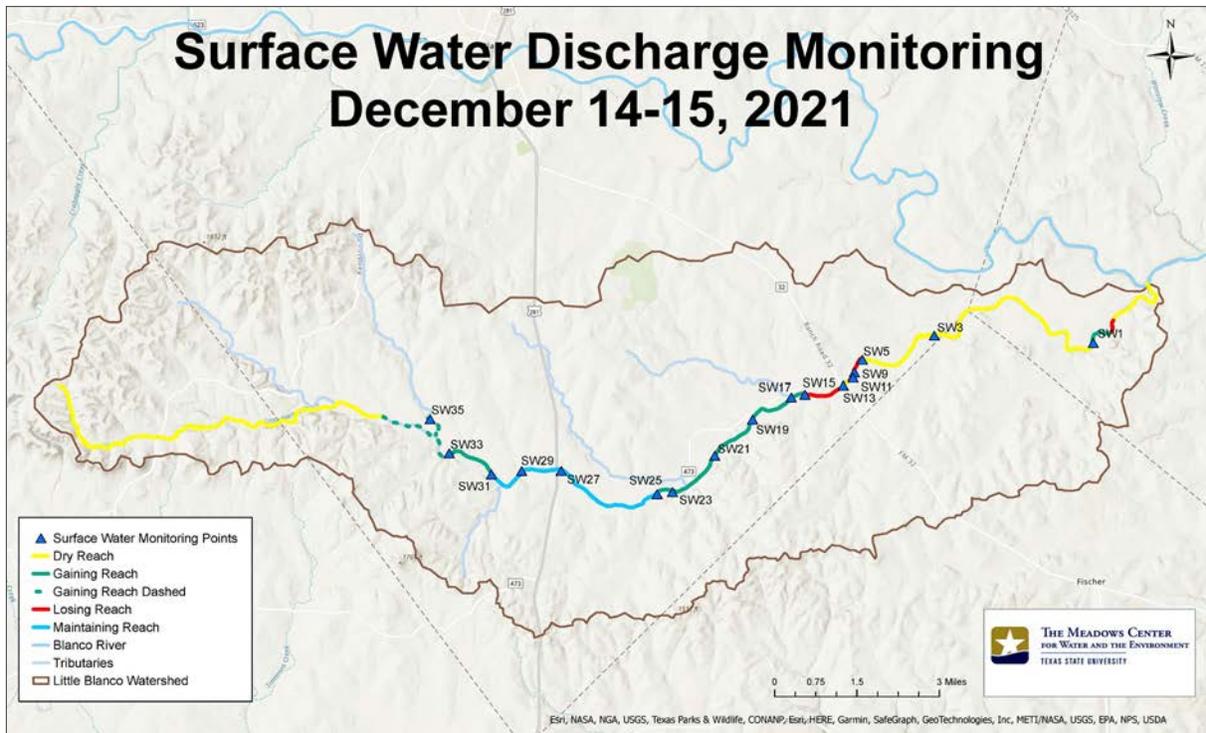
FIGURE 25. SURFACE WATER DISCHARGE MONITORING, DECEMBER 2021

From SW33 to SW31, flow increased by roughly 50 percent. For the next several miles, there was little change in discharge. There may have been a slight loss of water into the alluvial deposits, or simple measurement differences. Discharge increases from SW25 to SW 15, a little less than a mile from RR 32. From SW15 to SW5, the river loses all its flow, with the largest losses beginning near the USGS gauge and continuing to SW5. Several observations at road crossings further downstream indicate no flow.

Calcium and sulfate show a trend of increasing downstream. Figure 34 is a graph of sulfate and calcium versus river mile. Both parameters show a significant increase in concentration near River Mile 9. The source of the increased calcium and sulfate is likely dissolution of the gypsum beds near the base of the Upper Glen Rose. This is the same reach of the river that had significant gains in flow discharge (Figure 25).

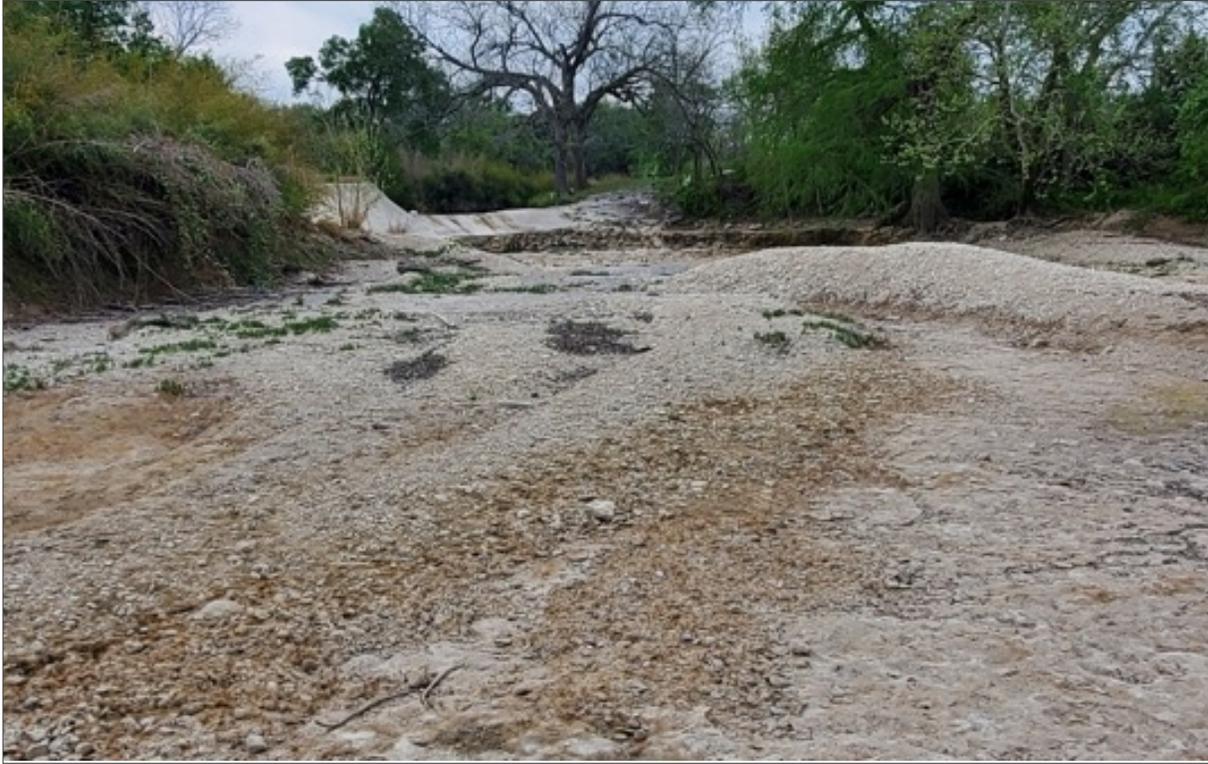
FIGURE 26. LOSING REACH LOOKING UPSTREAM TOWARD SW9.

An intent of the study was to conduct an additional synoptic event during higher discharge, but the lack of precipitation meant only declining flow. The losing reach between SW9 and SW5 completely dried up, allowing observations of the dry riverbed in this major losing reach (see Figures 26-27).

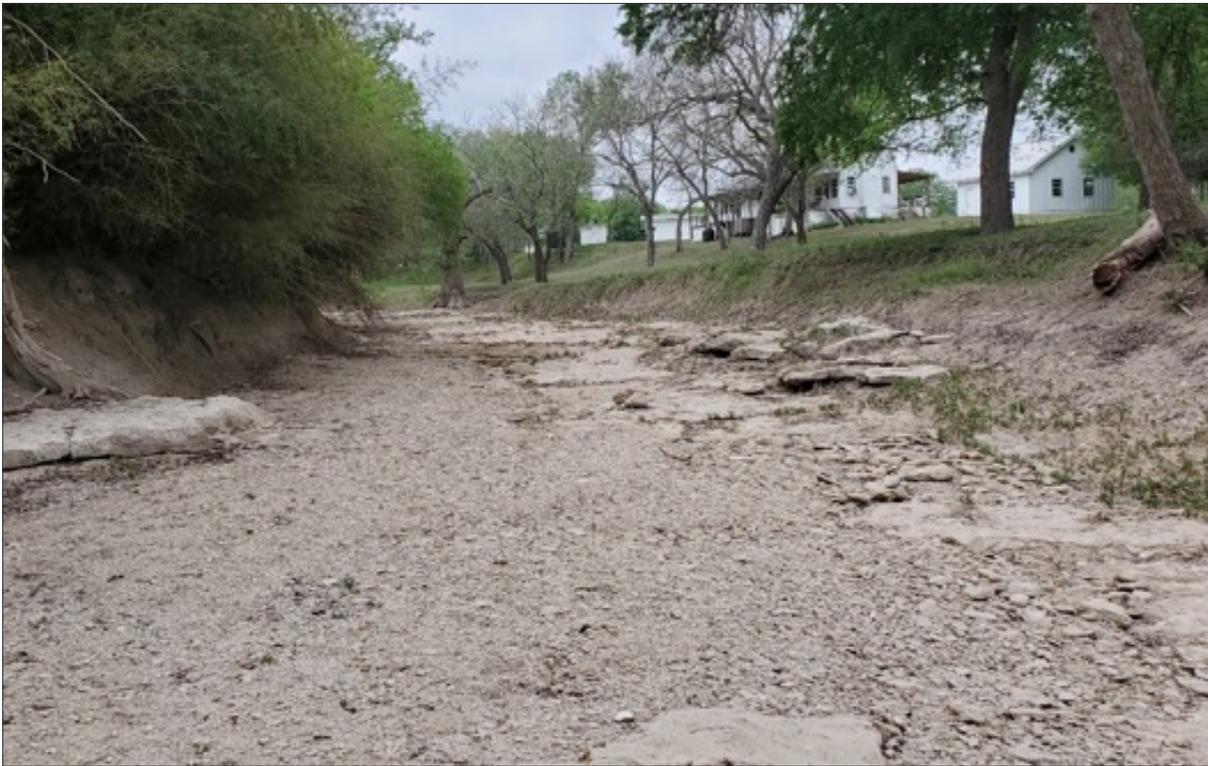
FIGURE 27. LOSING REACH NEAR SW5 NOTE: LOWER GLEN ROSE STREAM BOTTOM AND UNCONSOLIDATED TERRACE DEPOSITS ON BANKS

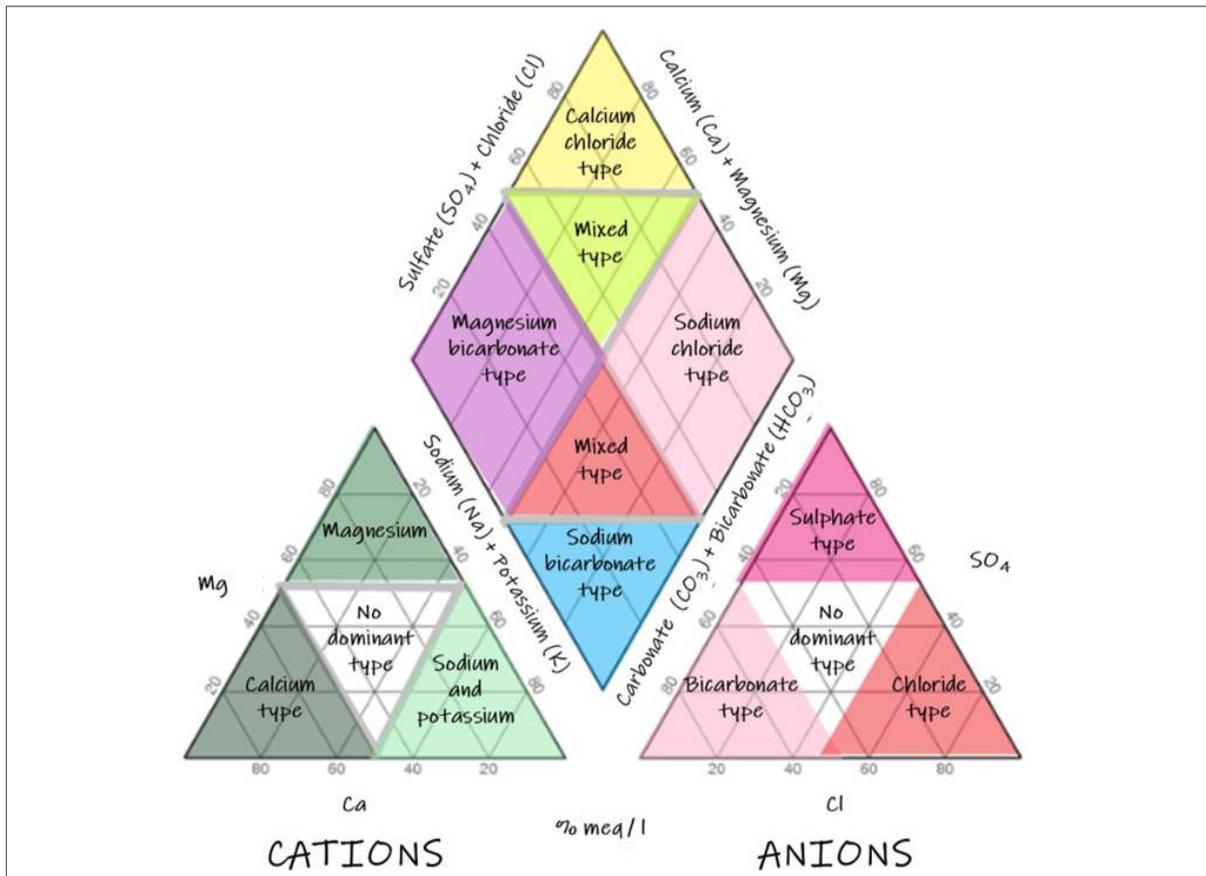
Several widely accepted methods of graphically representing water quality data are presented below: piper plots and stiff plots. Both methods are used to visualize the abundance of common, natural ions in water. The piper plot is a trilinear diagram comprised of a ternary diagram showing cations (lower left), a ternary diagram representing anions (lower right) and a rhombic plot in the middle (Figure 30). On a stiff diagram, the left side of the diagram shows cation concentrations and the right side shows anion concentrations. The further a point is from the center of the graph, the larger the ionic concentration. Both types of plots can be used to identify waters of similar origin.

FIGURE 30. PIPER PLOT SAMPLE SHOWING CLASSIFICATION OF WATERS BASED ON COMMON CATIONS AND ANIONS ([HTTPS://HATARILABS.COM/](https://hatarilabs.com/))

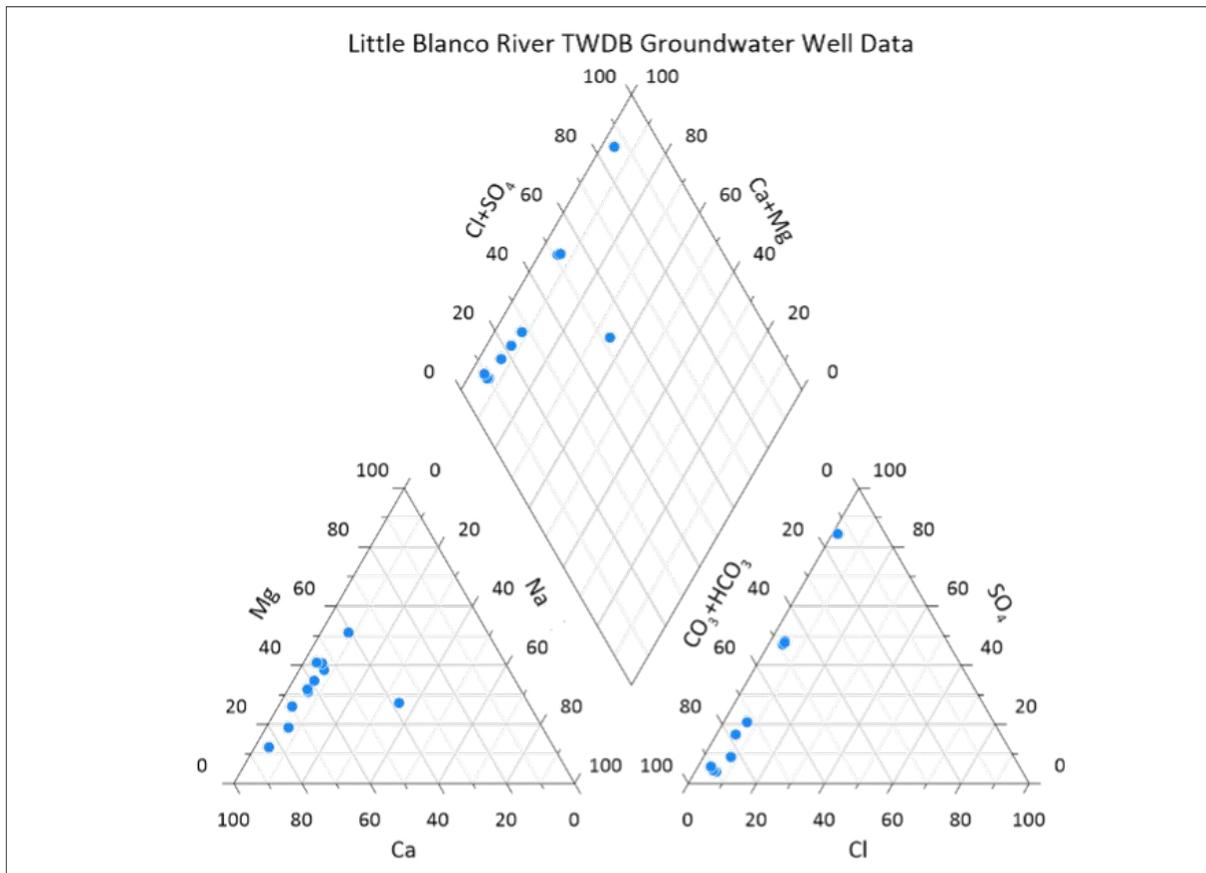
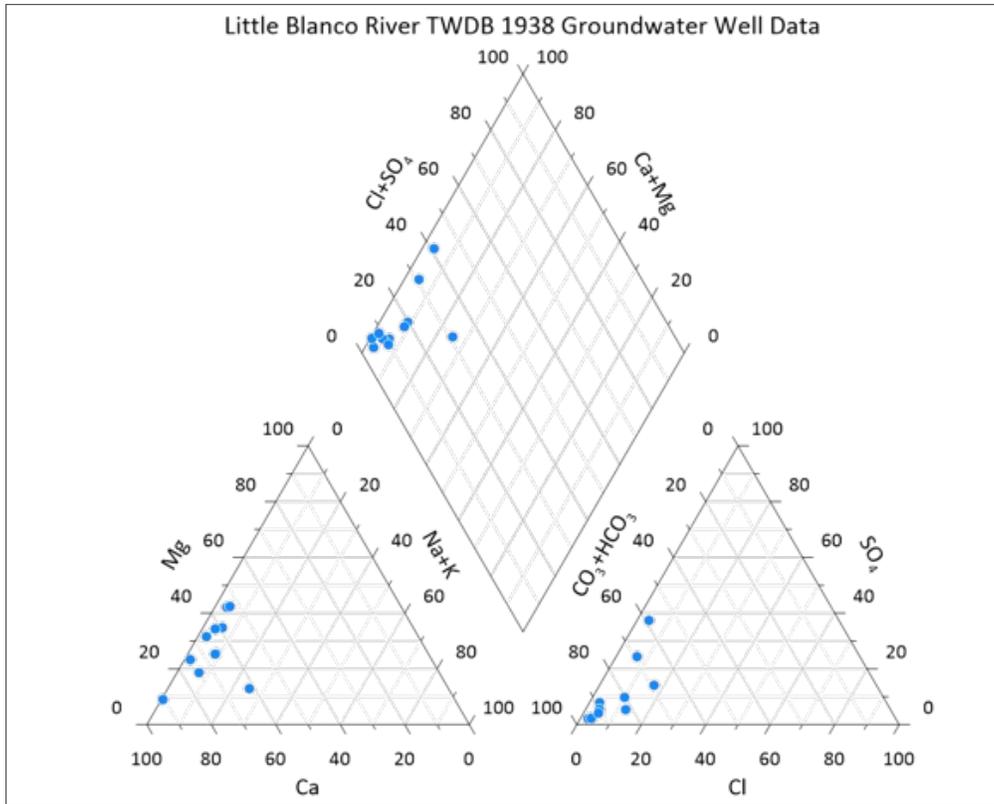
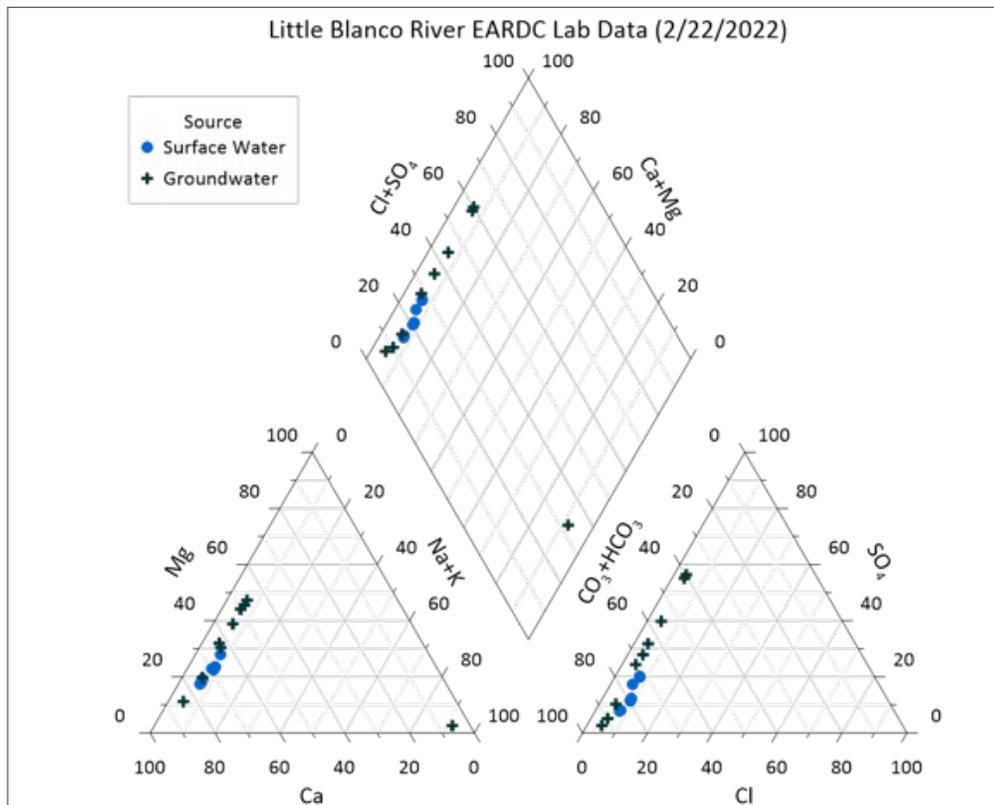
FIGURE 31. BLANCO RIVER TWDB 1938 GROUNDWATER WELL DATA

Figures 31-33 are piper plots developed from data in the Little Blanco River watershed. Figures 31 and 32 were developed using historic TWBD groundwater quality data. Figure 30 used data from the 1938 survey and is missing potassium data. Figure 32 shows data from after 1938 contained in the TWDB database. Figure 33 displays the Meadows groundwater and surface data collected during this study. The data indicates all waters to be of similar calcium magnesium bicarbonate type water. The aquifers in the watershed are carbonate in nature (limestone and dolomite). Calcium is the dominant cation in limestone with magnesium becoming more abundant in dolomite, so the classification is consistent with the aquifer type.

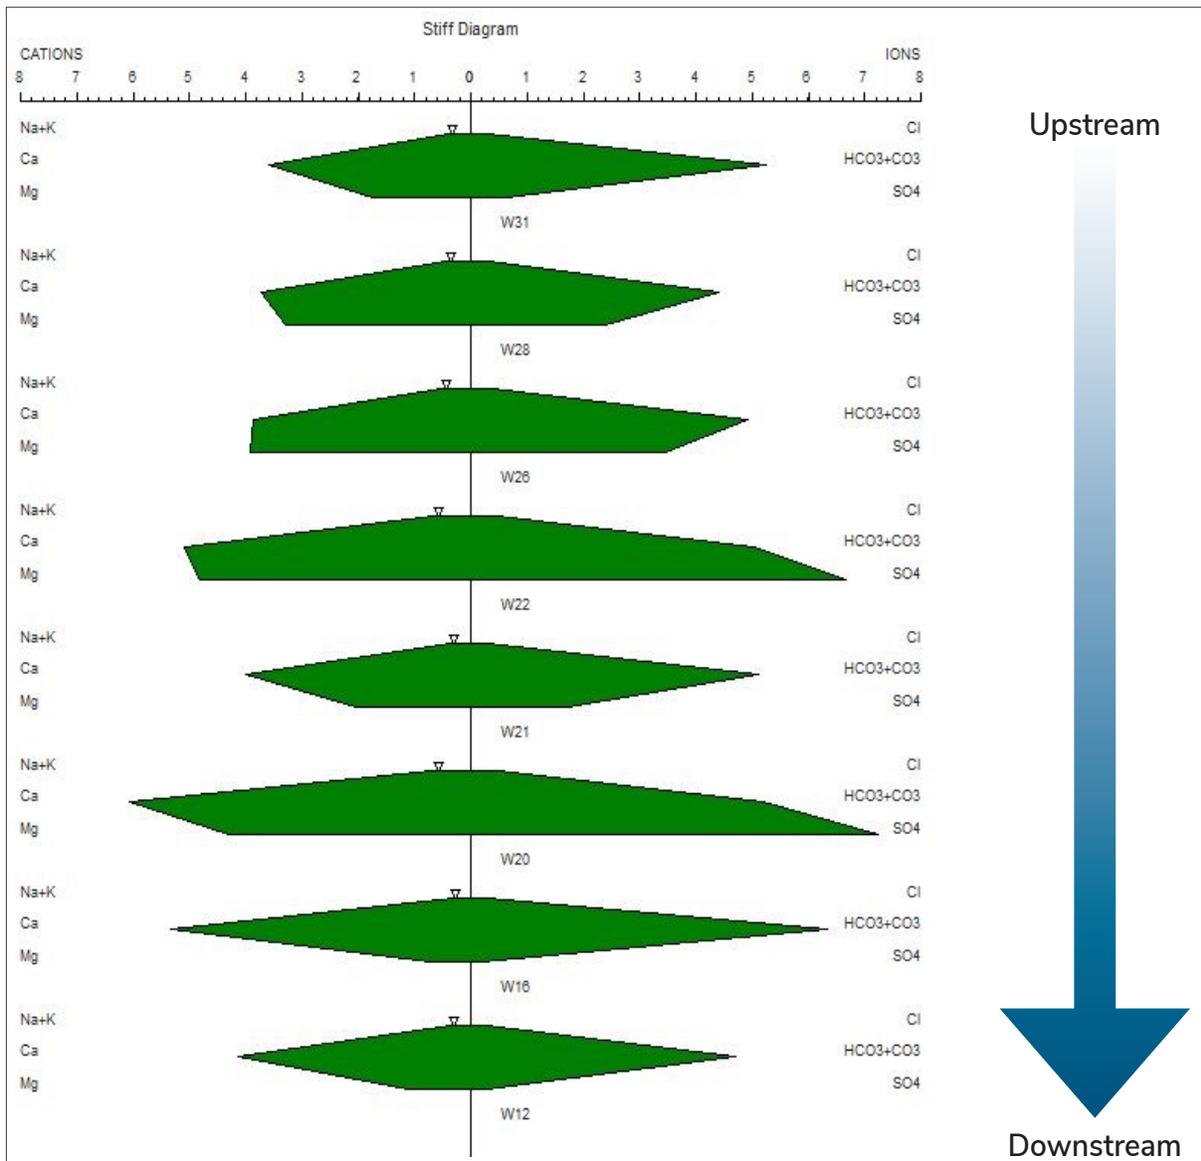
Stiff diagrams of groundwater samples collected during the study reflect more variable water quality as compared to surface water and the TWDB wells (Figure 37). Wells GW 21, GW 22 and GW 26 have higher magnesium and sulfate than other wells and surface water and are along the gaining reach of the river. The depths and completion aquifer(s) of these wells is not known, so it is difficult to interpret the data. The higher magnesium may indicate the wells are completed in the Cow Creek which is typically more dolomitic than the Hensel or Lower Glen Rose. Well GW 16 is located at the end of the losing reach and water quality tends to reflect surface water quality.

FIGURE 37. STIFF DIAGRAMS OF GROUNDWATER FROM MEADOWS STUDY WELLS (RESULTS ARE SHOWN WITH UPSTREAM DATA AT THE TOP AND DOWNSTREAM RESULTS AT THE BOTTOM)
